Coupled hydrogen and phosphorous induced initiation of internal cracks in a large 18MnNiMo5 component

Jean-Gabriel Sezgin, Cédric Bosch, Aurore Montouchet, Gilles Perrin, Andrej Atrens, Krzysztof Wolski

This study analyzed a crack in a scrapped 18MnNiMo5 80-tonne shell. The root cause of crack formation was the low fracture toughness caused by a combination of a high hydrogen content and phosphorous segregation, caused by an inappropriate heat treatment. Cracking initiated on MnS inclusion clusters enabled by hydrogen desorption at the MnS/matrix interfaces. Crack propagation was due to the internal hydrogen pressure causing the crack tip stress intensity factor to exceed the locally-reduced fracture toughness. This new hydrogen induced cracking (HIC) mechanism can be designated as Hydrogen Induced Localised Damage (HILD). Appropriate process controls can eliminate such defects.

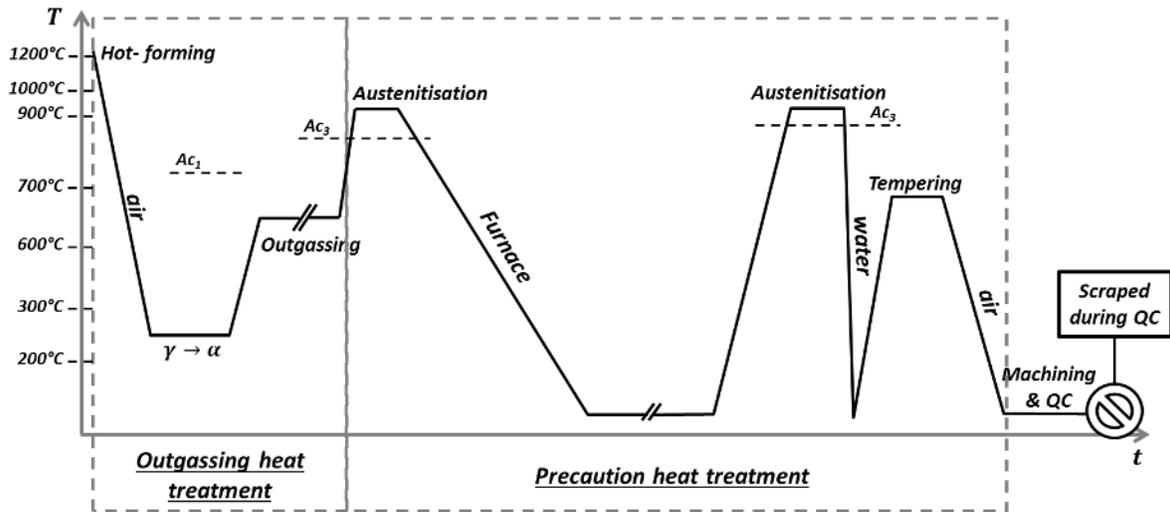
However, the heat treatment was more complex for the component being herein analyzed. Firstly, the standard hydrogen outgassing duration was applied, but it appears that this did not result in a sufficient hydrogen removal. Secondly, after the austenitisation, an unplanned slow cooling occurred in the furnace, instead of the scheduled water quenching. It is expected that this slow cooling produced a ferritic-pearlitic microstructure instead of the required bainitic microstructure produced by the water quenching. After the slow cooling to room temperature, the component was stored for the period of approximately two months. As such a slow cooling was inadequate to produce the required bainitic microstructure, the complete precaution heat treatment was then re-applied to the component. The component was austenitized for the second time, water quenched, tempered and cooled at 30 °C/h to room temperature. The component was machined to the required dimensions. Then, however, ultrasonic measurements revealed the presence of penny-shaped cracks, which led to the decision to stop the production, and scrap the component.

Figure 1 Heat treatment applied to the component. To comply with the microstructure requirements, a second austenitisation was performed after the unplanned furnace cooling. Nondestructive examination found penny-shaped cracks and the component was scrapped.

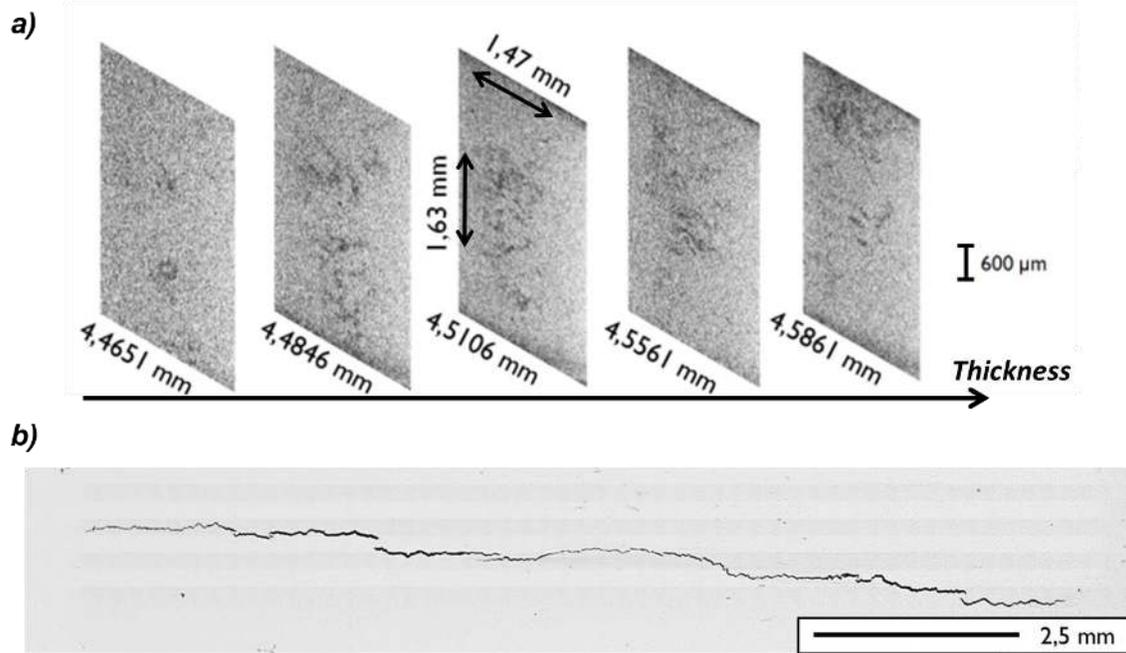
Ultrasonic inspection of the material made available to EMSE located a crack within a 30 mm x 30 mm x 40 mm bloc. A thinner sample was extracted from this bloc and analyzed by tomography (Figure 2-a) and by optical microscopy (Figure 2-b). The overall size of the crack was of the order of 20 mm in length on the cross section and its opening was 10 to 20 μm . The position of this crack within the microstructure is presented in Figure 3-a) (SEM image) and Figure 3-b) (EBSD image). The analysis of the crack path with respect to the microstructure usually is extremely helpful [23] [24] in determining the mechanisms of environmentally assisted fracture. However, in this particular case, the second austenitisation must be considered, and for the case the cracks were formed before this austenitisation, the EBSD analysis would be meaningless.

Figure 2 Observation of a crack withdrawn from the scraped component (a) by X-ray micro tomography and (b) by optical microscopy on the cross section

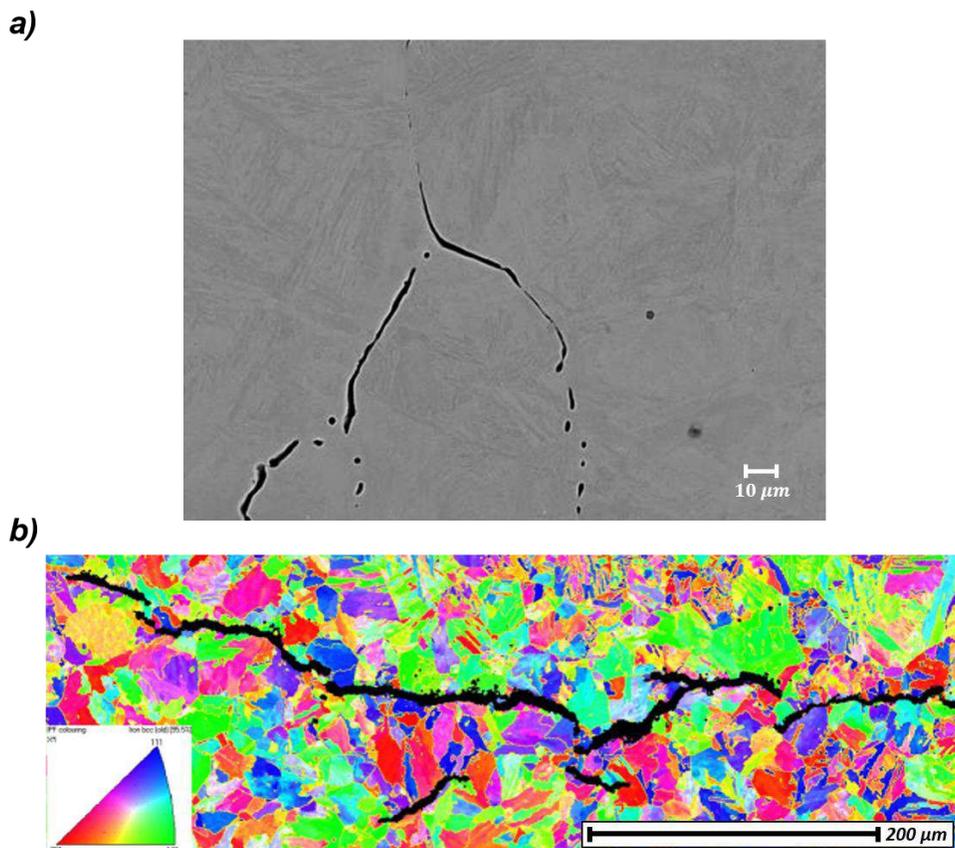
Figure 3 Observation of the crack in relationship to the microstructure (a) through SEM imagery (backscattered electron signal) and (b) EBSD mapping (IPF post processing)

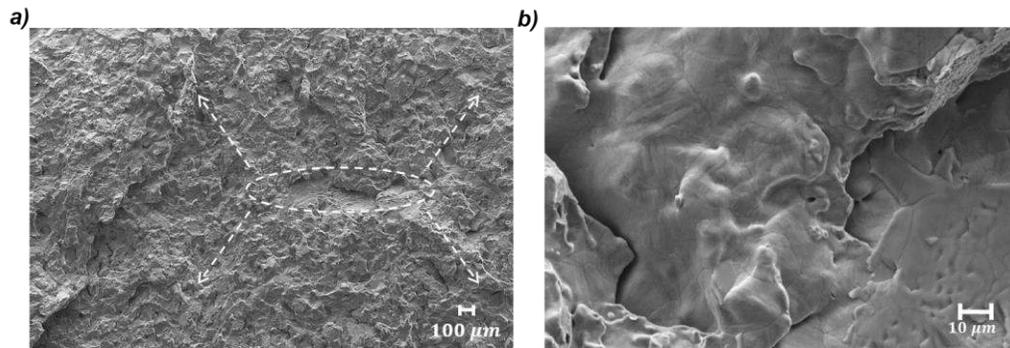
Figure 4a reveals that the crack may have started from the area indicated by a dashed ellipse and propagated in the radial direction. Such cracks usually initiate on microstructural defects [25] [26], including inclusions. Figure 4b) provides a magnification of the area within the ellipse of Figure 4a). This micrograph illustrates the smoothed topography of the surface and the presence of small thermal grooves on the surface that indicate that this crack was exposed to a temperature high enough for massive surface diffusion. Furthermore, the smoothing of the whole internal surface of the crack indicates that no propagation occurred after the last heat treatment. In particular, this observation indicates that this crack could not have formed during the one-month period (dedicated to the machining to final dimensions and necessary to perform ultrasonic measurements, see “machining & QC” in Figure1) at room temperature prior the final quality control.

Figure 4 SEM micrograph of the fracture surface of the crack extracted from the component. a) Possible crack initiation site is indicated by the white dashed ellipse. b) The generalized smoothed crack topography indicates that the crack was exposed to high temperatures after crack formation

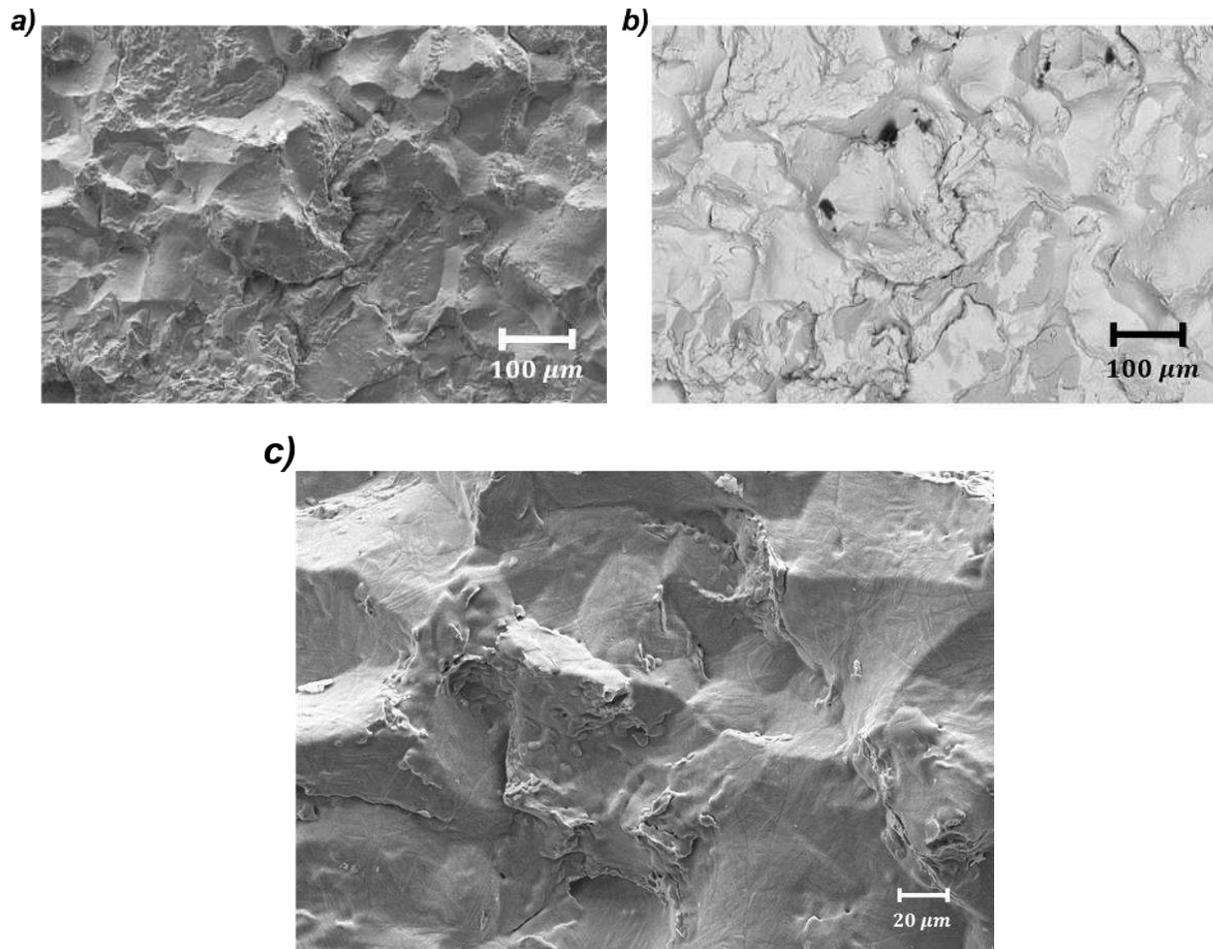
Figure 5a) presents an area of mainly intergranular fracture. Figure 5b) presents the same area using backscattered electrons. The contrast at the bottom of the micrograph indicates a series of MnS inclusions forming a large cluster in the immediate vicinity of the intergranular facets. Figure 5c) is a magnification of an area located at the left of Figure 5a). It represents mainly intergranular facets, located on the top of the micrograph, together with some transgranular facets. The smoothing induced by heat treatment may have altered the details of the type of fracture mode and have hidden additional features such as secondary cracks. The mainly intergranular fracture was only present on a limited area of the whole fracture surface, which was mainly transgranular and smoothed, as illustrated in Figure 4a) at low magnification and Figure 4b) at high magnification.

Figure 5 Evidence for large intergranular areas containing MnS inclusions. a) SEM micrograph of a fracture surface of the crack extracted from the component showing a large area of mainly intergranular fracture which was smoothed. b) The same area viewed by backscattered electrons showing several MnS inclusions (grey areas at the bottom) close to the intergranular facets. c) Smoothed intergranular facets.
