Coupled hydrogen and phosphorous induced initiation of internal cracks in a large 18MnNiMo5 component

This study analyzed a crack in a scrapped 18MnNiMo5 80-tonne shell. The root cause of crack formation was the low fracture toughness caused by a combination of a high hydrogen content and phosphorous segregation, caused by an inappropriate heat treatment. Cracking initiated on MnS inclusion clusters enabled by hydrogen desorption at the MnS/matrix interfaces. Crack propagation was due to the internal hydrogen pressure causing the crack tip stress intensity factor to exceed the locally-reduced fracture toughness. This new hydrogen induced cracking (HIC) mechanism can be designated as Hydrogen Induced Localised Damage (HILD). Appropriate process controls can eliminate such defects.

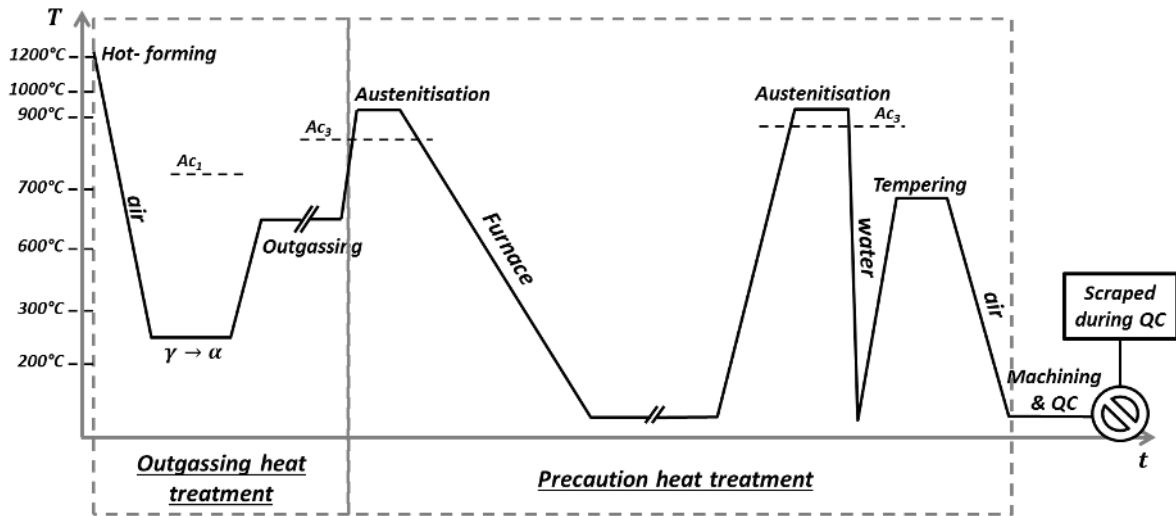
However, the heat treatment was more complex for the component being herein analyzed. Firstly, the standard hydrogen outgassing duration was applied, but it appears that this did not result in a sufficient hydrogen removal. Secondly, after the austenitisation, an unplanned slow cooling occurred in the furnace, instead of the scheduled water quenching. It is expected that this slow cooling produced a ferritic-pearlitic microstructure instead of the required bainitic microstructure produced by the water quenching. After the slow cooling to room temperature, the component was stored for the period of approximately two months. As such a slow cooling was inadequate to produce the required bainitic microstructure, the complete precaution heat treatment was then re-applied to the component. The component was austenitized for the second time, water quenched, tempered and cooled at 30 °C/h to room temperature. The component was machined to the required dimensions. Then, however, ultrasonic measurements revealed the presence of penny-shaped cracks, which led to the decision to stop the production, and scrap the component.

Figure 1 Heat treatment applied to the component. To comply with the microstructure requirements, a second austenitisation was performed after the unplanned furnace cooling. Nondestructive examination found penny-shaped cracks and the component was scrapped.

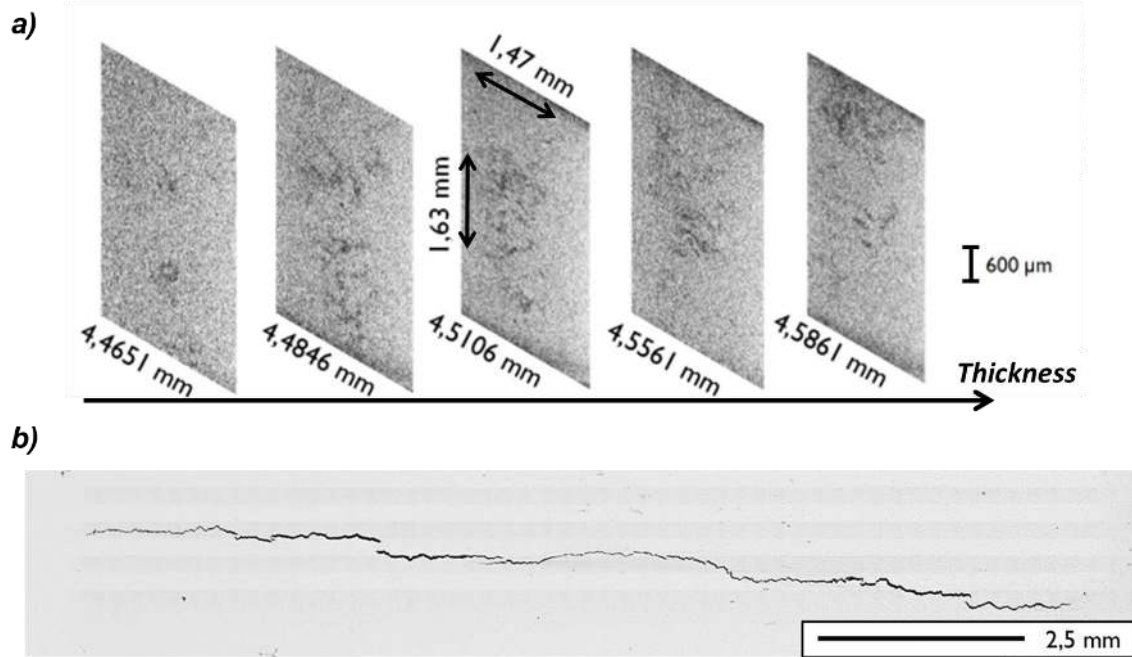
Ultrasonic inspection of the material made available to EMSE located a crack within a 30 mm x 30 mm x 40 mm bloc. A thinner sample was extracted from this bloc and analyzed by tomography (Figure 2-a) and by optical microscopy (Figure 2-b). The overall size of the crack was of the order of 20 mm in length on the cross section and its opening was 10 to 20 μm . The position of this crack within the microstructure is presented in Figure 3-a) (SEM image) and Figure 3-b) (EBSD image). The analysis of the crack path with respect to the microstructure usually is extremely helpful [23] [24] in determining the mechanisms of environmentally assisted fracture. However, in this particular case, the second austenitisation must be considered, and for the case the cracks were formed before this austenitisation, the EBSD analysis would be meaningless.

Figure 2 Observation of a crack withdrawn from the scraped component (a) by X-ray micro tomography and (b) by optical microscopy on the cross section

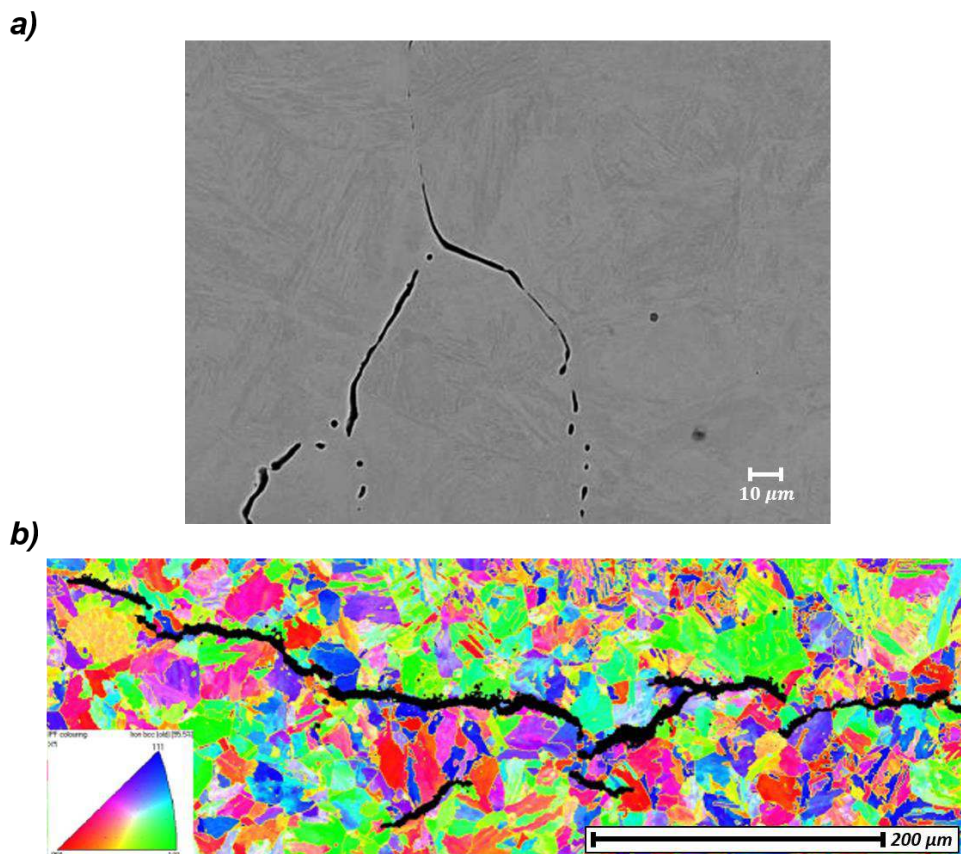
Figure 3 Observation of the crack in relationship to the microstructure (a) through SEM imagery (backscattered electron signal) and (b) EBSD mapping (IPF post processing)

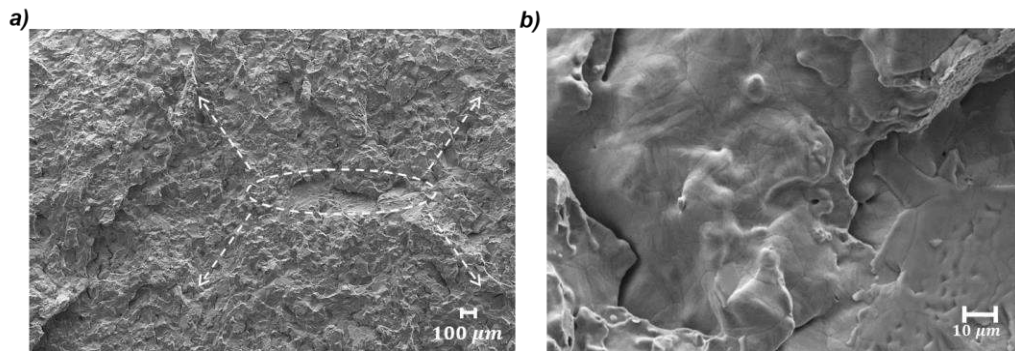
Figure 4a reveals that the crack may have started from the area indicated by a dashed ellipse and propagated in the radial direction. Such cracks usually initiate on microstructural defects [25] [26], including inclusions. Figure 4b) provides a magnification of the area within the ellipse of Figure 4a). This micrograph illustrates the smoothed topography of the surface and the presence of small thermal grooves on the surface that indicate that this crack was exposed to a temperature high enough for massive surface diffusion. Furthermore, the smoothing of the whole internal surface of the crack indicates that no propagation occurred after the last heat treatment. In particular, this observation indicates that this crack could not have formed during the one-month period (dedicated to the machining to final dimensions and necessary to perform ultrasonic measurements, see “machining & QC” in Figure1) at room temperature prior the final quality control.

Figure 4 SEM micrograph of the fracture surface of the crack extracted from the component. a) Possible crack initiation site is indicated by the white dashed ellipse. b) The generalized smoothed crack topography indicates that the crack was exposed to high temperatures after crack formation

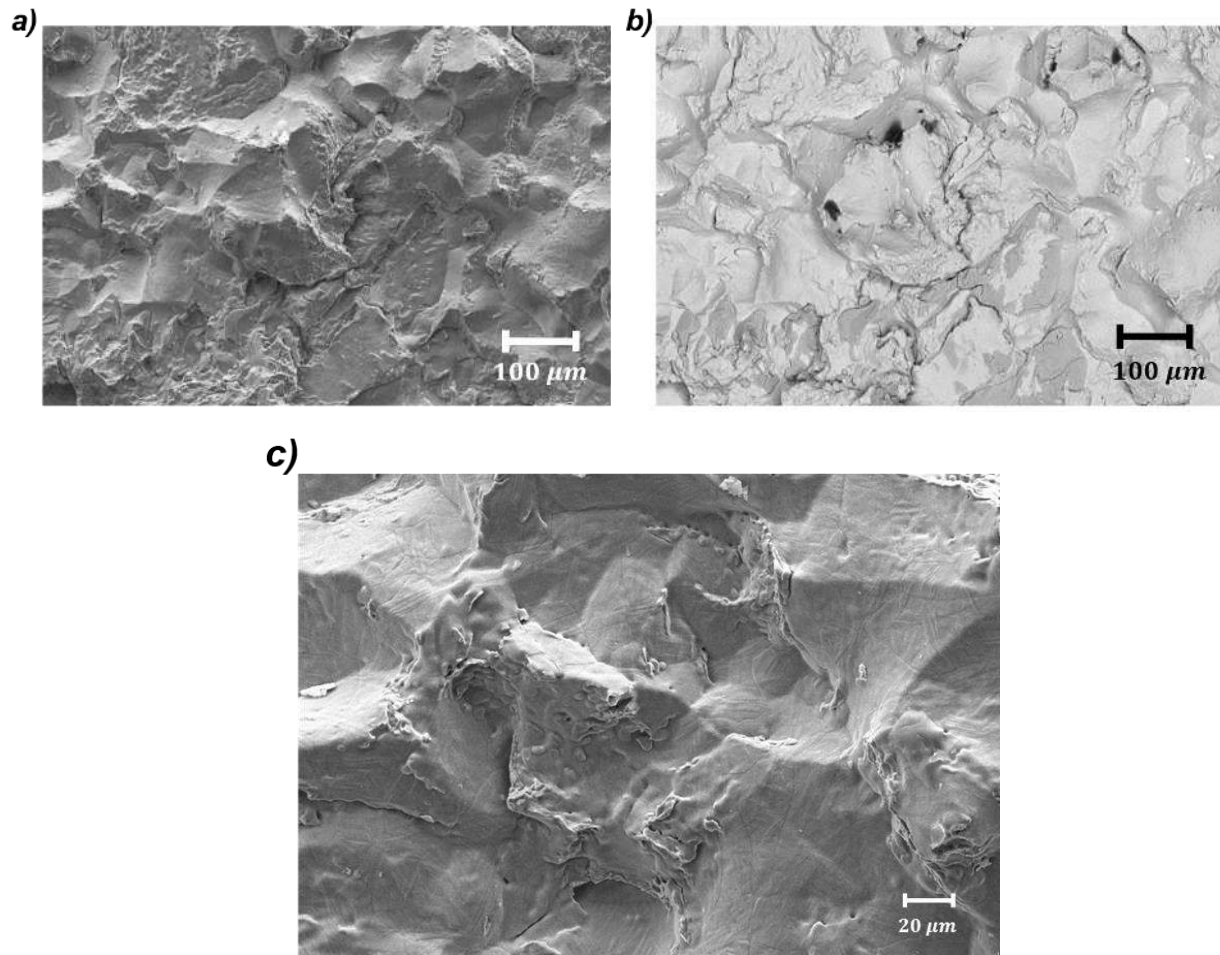
Figure 5a) presents an area of mainly intergranular fracture. Figure 5b) presents the same area using backscattered electrons. The contrast at the bottom of the micrograph indicates a series of MnS inclusions forming a large cluster in the immediate vicinity of the intergranular facets. Figure 5c) is a magnification of an area located at the left of Figure 5a). It represents mainly intergranular facets, located on the top of the micrograph, together with some transgranular facets. The smoothing induced by heat treatment may have altered the details of the type of fracture mode and have hidden additional features such as secondary cracks. The mainly intergranular fracture was only present on a limited area of the whole fracture surface, which was mainly transgranular and smoothed, as illustrated in Figure 4a) at low magnification and Figure 4b) at high magnification.

Figure 5 Evidence for large intergranular areas containing MnS inclusions. a) SEM micrograph of a fracture surface of the crack extracted from the component showing a large area of mainly intergranular fracture which was smoothed. b) The same area viewed by backscattered electrons showing several MnS inclusions (grey areas at the bottom) close to the intergranular facets. c) Smoothed intergranular facets.

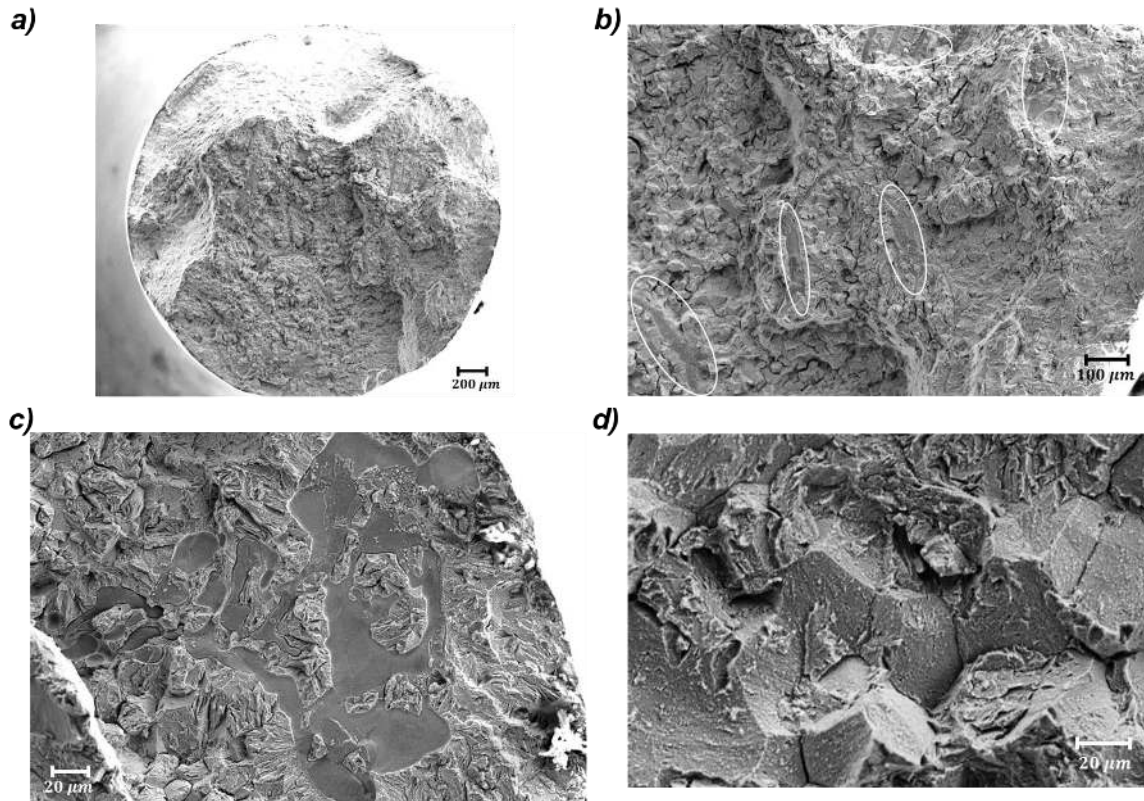
Figure 11 presents the fracture surface corresponding to the specimen with the bainitic microstructure and tested under condition 1. Figure 11a) presents an overview of the fracture surface. The fracture surface indicates crack initiation at the specimen surface at the bottom of the figure, and crack propagation towards the center of the specimen, followed by final fracture. The reduction of area and almost no necking indicate a macroscopically-brittle fracture of the specimen. The fact that there was necking indicated that the hydrogen induced cracking occurred at or after the ultimate tensile strength. This behavior explains the stress-strain curve from Figure 10b). Detailed observation revealed an abundance of MnS clusters as indicated in Figure 11b). This micrograph also indicates the presence of some ductility, which confirms the assumption of a curve governed by the centripetal crack propagation. This indicates that the brittle fracture occurred first, inducing a stress drop in this strain-controlled SSRT. This effect was followed by a subsequent failure of ductile ligaments. The brittle areas were mostly transgranular but Figure 11c) shows some intergranular regions located nearby MnS. This fact is emphasized in Figure 11d).

Figure 11 Fracture observation of the bainitic tensile specimen under the first hydrogen loading condition a) global view of the fracture surface, b) presence of elongated MnS inclusions enhancing HE contained in the white elliptic marks c) mixed transgranular-intergranular brittle fracture nearby MnS inclusions (dark smooth surfaces) with some ductile areas, and d) magnification of an intergranular fracture area, located close to MnS inclusions.

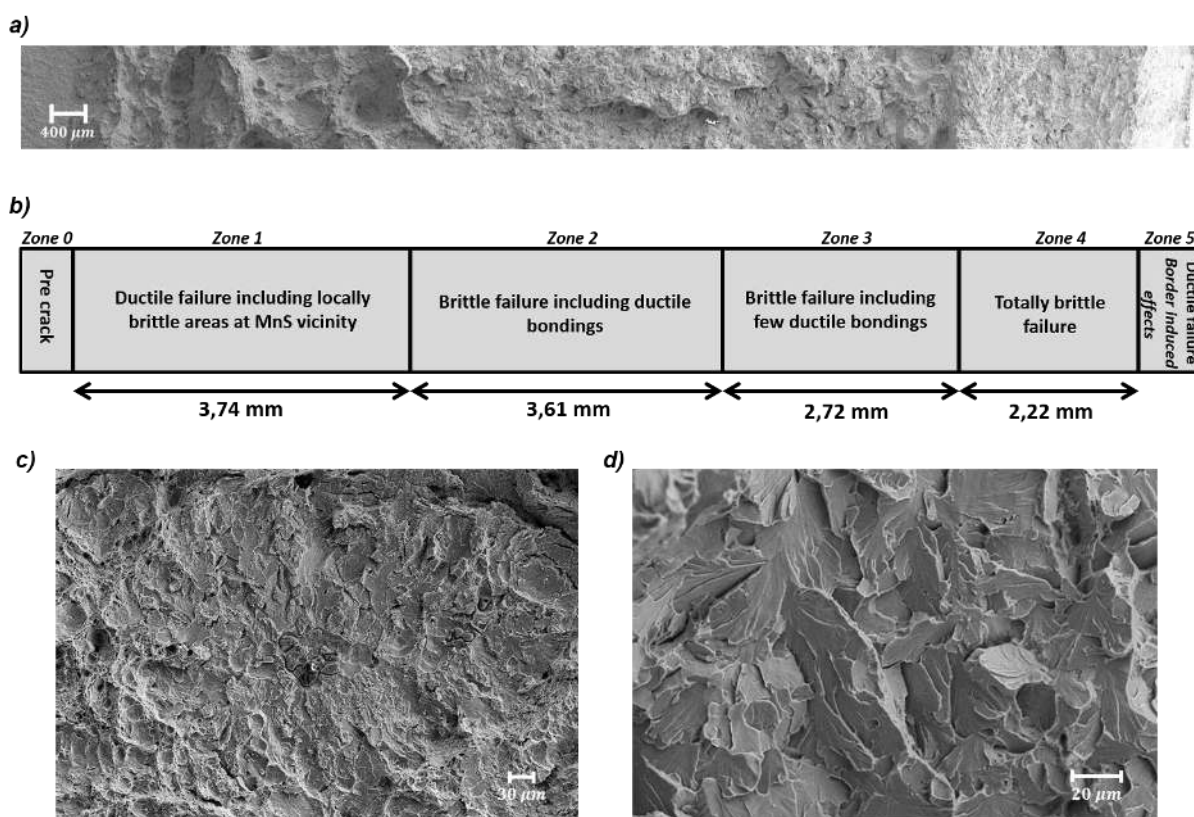
Figure 12 presents different aspects of the resulting fracture surface. Figure 12a) presents a global view. At this magnification, a progressive transition from ductile to brittle failure suggests a heterogeneous effect of hydrogen. This progression has been schematized in Figure 12b) which identifies several areas. Near the pre-crack in zone 0, the failure was mainly ductile with some embrittled areas located near MnS inclusions. The fracture path changed to a brittle mode in zones 2-4. These zones are characterized by the continuous reduction of ductility (e.g. ligaments) with increasing crack length. Figure 12c) presents a micrograph focusing on an embrittled area located in the vicinity of the MnS-inclusion in zone 2. Figure 12d) presents a micrograph focused on a representative area of zone 4. This zone was fully brittle transgranular with no trace of ductility.

Figure 12 Fracture surface obtained after a fracture toughness test under hydrogen charging conditions at $-1200 \text{ mV}_{\text{SCE}}$ in 30 g L^{-1} NaCl for 96 h. a) Overview SEM macrograph of the fracture surface. b) Schematic of the different areas on this fracture surface. c) Focus on an elliptic brittle area surrounding several MnS inclusions in the zone 2. d) Fully brittle fracture in zone 4.
