## Oxidation of austenitic stainless steels in PWR primary water

Antoine Herbelin, Thierry Couvant, Laurent Legras, David Delafosse, Gabriel Ilbevere

Antoine Herbelin, Thierry Couvant, Laurent Legras, David Delafosse, Gabriel Ilbevere. Oxidation of austenitic stainless steels in PWR primary water. European Corrosion Congress 2009 (EUROCORR 2009), Sep 2010, Nice, France. pp.1592-1608. emse-01063711

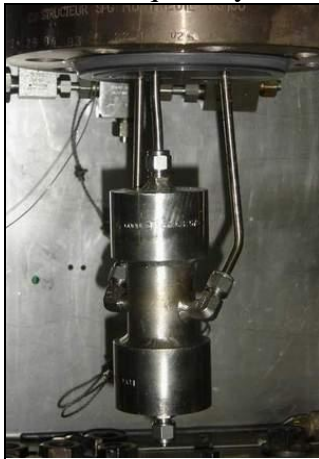
Figure 2 – Capsule for short exposure to primary water. Figure 3 – Evolution of the temperature during testing in capsule.

A short exposure test was carried out in a specifically designed capsule placed in an autoclave (Figure 2). A specimen was introduced in the capsule, after tensile pre-deformation at room temperature (specimen 1171-13, 304L, heat T2575, strained to 40%). The test in primary water at 320°C lasted 6h (2h heating and 4h at 320°C), then a rapid decrease of temperature was obtained by the injection of cold pure water in the capsule (Figure 3). After testing, thin foils were cut to quantify the surface oxides.

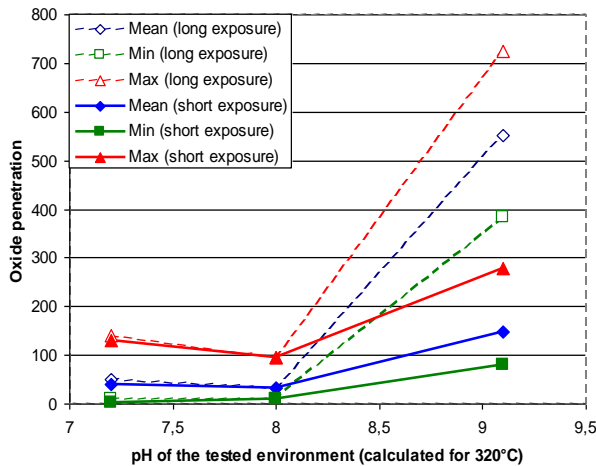
**Figure 30** shows the effects of pH on the oxide growth, using the results from tests on specimen with machined surfaces. First, a decrease on the oxide penetration can be seen at pH 8 and a significant increase at pH 9.1. Secondly, comparing the durations of the various tests at pH 7.2 and pH 9.1, pH could also have a significant impact on the oxide penetration kinetics. At pH 7.2, stabilization of the Chromium passive layer seems to occur after a few hours of exposition ; 40 nm after 4h, 50 nm after 17000h (50 nm after 500h for cross test specimen on low deformation areas). On the other hand, at pH 9.2 the oxide is still actively penetrating the metal surface after hundreds of hours (150 nm after 240h, 550 after 5000h). **Figure 31** illustrates the possible evolution of the average oxide penetration as a function of time for pH 7.2 and pH 9.1, fitting the result and assuming a saturating law (Evans type). This would indicate a critical change in chemical behavior, bringing into question the passivity of the chromium layer at pH 9.2, as well as pointing out possible effects of occluded environments of high alkalinity on oxide growth and SCC cracking.

**Figure 30** – Oxide penetration as a function of pH (machined surfaces)

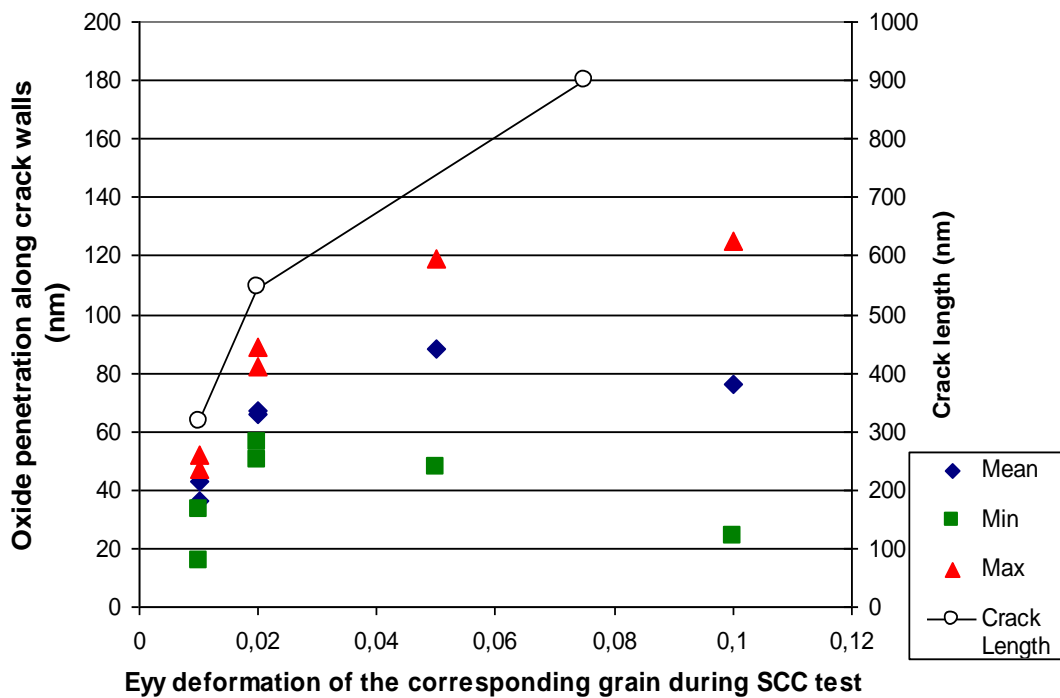
**Figure 33** shows the evolution of oxidation depth along the crack walls and crack length as a function of local deformation during the test (second  $E_{yy}$ ). Observations are consistent with the surface observations, indicating a deeper penetration in areas with higher levels of deformation. Crack length seems to be correlated to local deformation in a similar way. Again, the crack at site 1 stands out, as seen on the EFTEM image (**Figure 26**). At a higher level of deformation, it is the longest crack and highest maximum oxide penetration along the crack walls. However, as indicated above, closer to the tip, the oxide thickness decreases. This may indicate that the crack was still active at the end of the test, achieving a deeper penetration and passivity where the crack initiated and thinner penetration in later exposed surfaces after a propagation step. From this case, and assuming the other two cracks experienced only one cracking event, this would indicate that the typical intergranular cracking step is between 200 nm and 500 nm. This information is valuable for the general understanding of SCC mechanisms, as it defines an area where investigations about the cracking factors should be led, and sets a representative length scale for future mechanistic modeling of intergranular cracking.

**Figure 33** – Oxidation of the crack walls and crack length as a function of deformation
