Oxidation of austenitic stainless steels in PWR primary water

Antoine Herbelin, Thierry Couvant, Laurent Legras, David Delafosse, Gabriel Ilbevere. Oxidation of austenitic stainless steels in PWR primary water. European Corrosion Congress 2009 (EUROCORR 2009), Sep 2010, Nice, France. pp.1592-1608. emse-01063711

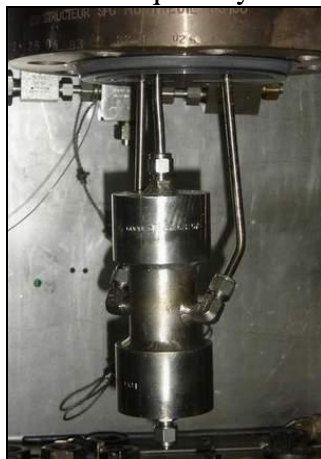
A short exposure test was carried out in a specifically designed capsule placed in an autoclave (Figure 2). A specimen was introduced in the capsule, after tensile pre-deformation at room temperature (specimen 1171-13, 304L, heat T2575, strained to 40%). The test in primary water at 320°C lasted 6h (2h heating and 4h at 320°C), then a rapid decrease of temperature was obtained by the injection of cold pure water in the capsule (Figure 3). After testing, thin foils were cut to quantify the surface oxides.

Figure 2 – Capsule for short exposure to primary water.

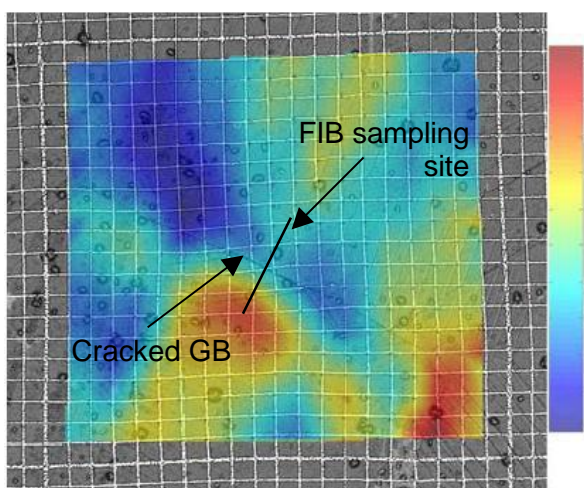
Figure 4 – Pre-deformation E_{xx} (in ambient air) on initiation site 1 at the surface of specimen 1594-T217-01 (316L)

Several sampling locations were chosen at the surface of the two cross-shaped specimens 1594-T112-06 and 1594-T217-01, based on the deformation measurements and SEM observations of crack initiation. **Figure 4** and **Figure 5** give an example of such a correlation for the site 1 on 1594-T217-01. The site was centered on an intergranular crack between two grains exhibiting different levels of deformation. The level of pre-deformation E_{xx} in ambient air and second deformation E_{yy} in primary water corresponding to the sampling for TEM examinations are reported in Table 5.

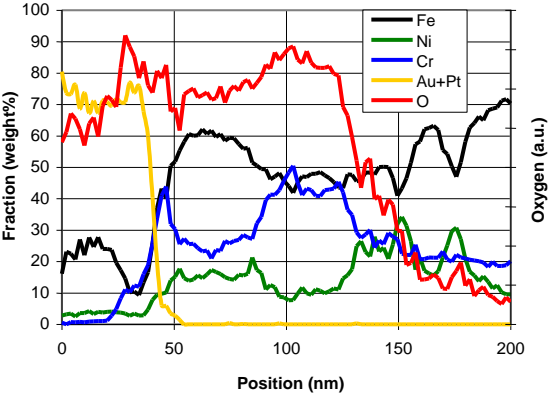
Figure 7 is an EDS scan corresponding to the previous site (at the location of the remaining gold grid). Oxygen content is plotted in arbitrary units, while Fe, Cr, Ni and Au+Pt contents are plotted in weight %. O and Ni contents slightly increase within the 200 nm – 130 nm depth range. Conversely, Fe content decreases and Cr content does not change. It can be noticed also that Ni maximum correspond to minima in Fe and O content. This observation suggests that only a limited fraction of Ni (noble element) is affected by oxidation, contrary to Fe and Cr.

Figure 7 – EDS profile. Site 1A at the surface of specimen 1594-T112-06 (304L).

The important decrease of the Fe content indicates that oxidation essentially affects Fe. Within the range 130 nm – 90 nm, Fe and Cr contents are equivalent (45%) and significantly higher compared to Ni content (10%). Therefore, a significant Cr enrichment is observed in this inner oxide layer. It can be assumed that Fe diffusion is more effective than Cr diffusion in this layer. Within the range 90 nm – 45 nm, the oxide is essentially composed of Fe (60%), even if Cr (25%) and Ni (15%) are present. This outer oxide layer is probably essentially composed of Fe spinels. The total thickness of the oxide is approximately 150 nm, including 40 nm of Cr-rich oxide.

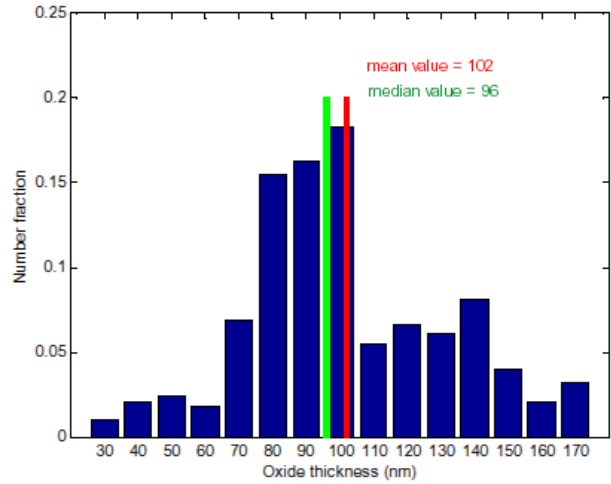
Figure 12 - Distribution of the thickness of the rich-Cr inner oxide layer formed at the surface of specimen T112-06 on site 1A (304L)

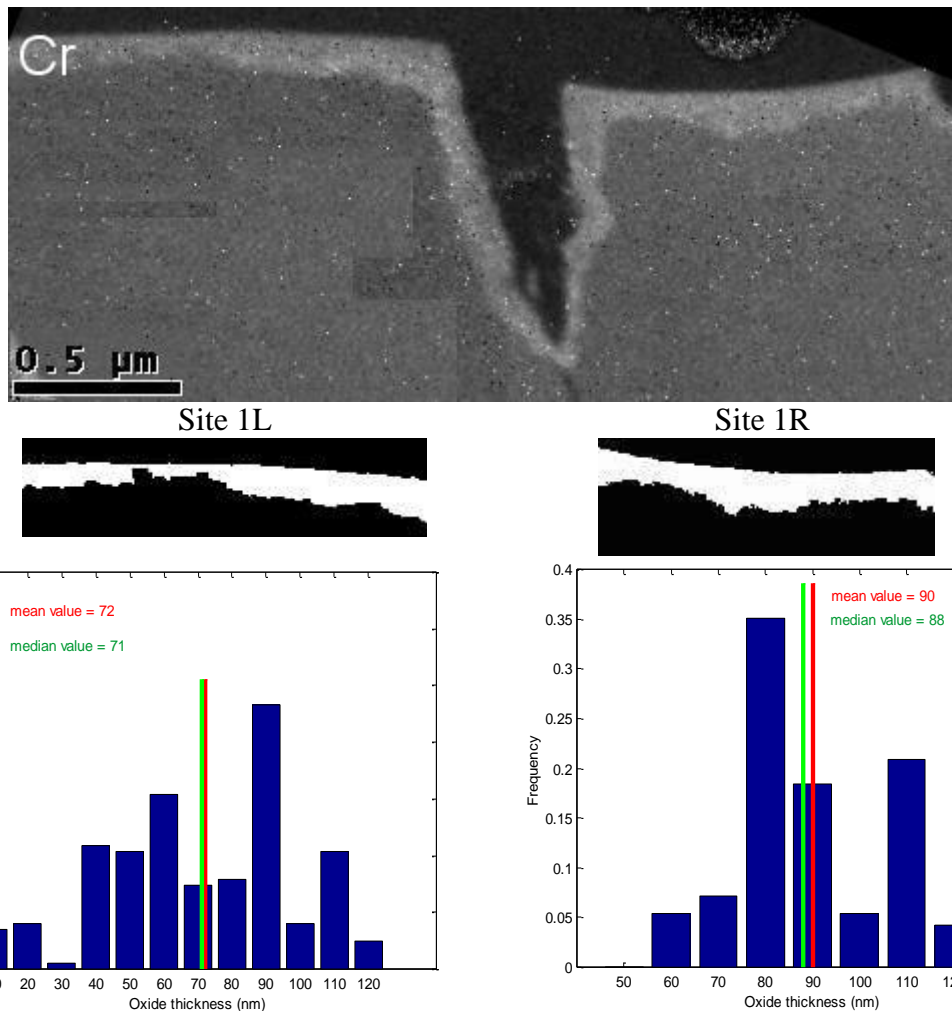
Figure 13 – EFTEM analysis of Cr-rich inner oxide layer at the surface of specimen T217-01 on site 1 (316L)

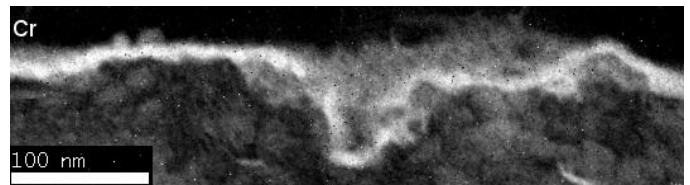
Figure 19 – EFTEM map of Cr-rich inner oxide layer at the surface of specimen 1171H4 (pH 8 – 600h)

Specimens T112-35, 1171H4, 1512-10 and 1512-22 were tested in PWR water at different pH values and during various exposition times. All specimen had a grinding surface finish and samples were cut in areas unaffected by deformation in ambient air or during the test. **Figure 18**, **Figure 19** and **Figure 20** show Cr-rich analysis examples for specimen T112-35, 1171H4, 1512-10, exposed to environments where pH = 7.2, 8 and 9.2, respectively. They display comparable oxides morphologies with clear maxima. The oxide penetration is significantly lower at pH 7.2 and 8 (30 +/- 20 nm) than at pH 9.1 (150 +/- 65 nm). On **Figure 21** are shown the results for specimen 1512-22, also tested at pH 9.1 during 5000h (to be compared to 240h for specimen 1512-10). The penetration is more important (550 +/- 70 nm) and the morphology is different: the oxide layer seems now homogeneous. Table 6 summarizes the analyses performed on specimens with machined surfaces.

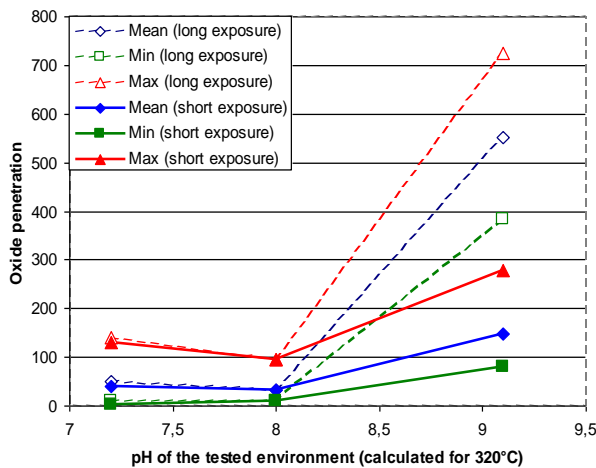
Figure 30 shows the effects of pH on the oxide growth, using the results from tests on specimen with machined surfaces. First, a decrease on the oxide penetration can be seen at pH 8 and a significant increase at pH 9.1. Secondly, comparing the durations of the various tests at pH 7.2 and pH 9.1, pH could also have a significant impact on the oxide penetration kinetics. At pH 7.2, stabilization of the Chromium passive layer seems to occur after a few hours of exposition ; 40 nm after 4h, 50 nm after 17000h (50 nm after 500h for cross test specimen on low deformation areas). On the other hand, at pH 9.2 the oxide is still actively penetrating the metal surface after hundreds of hours (150 nm after 240h, 550 after 5000h). **Figure 31** illustrates the possible evolution of the average oxide penetration as a function of time for pH 7.2 and pH 9.1, fitting the result and assuming a saturating law (Evans type). This would indicate a critical change in chemical behavior, bringing into question the passivity of the chromium layer at pH 9.2, as well as pointing out possible effects of occluded environments of high alkalinity on oxide growth and SCC cracking.

Figure 30 – Oxide penetration as a function of pH (machined surfaces)

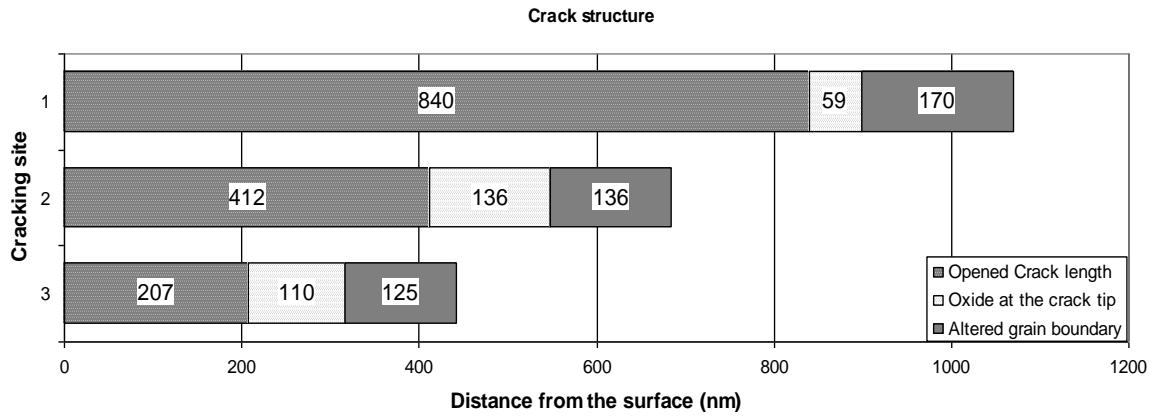
The crack tip in site 1 exhibits a different morphology; closer to the tip, the oxide layer on the crack walls gets thinner and the crack tip doesn't show any preferential oxidation along the grain boundary. The crack is twice longer (almost 1 μm) than the other so this could be seen as an effect of the crack length: the transport of the oxidizing species is less effective the longer the crack is. Additionally, the grain boundary ahead is also the most affected (almost 200 nm): the tip and affected region sum up to reach an equivalent level the other cracks. This fact could mean that the crack was still active at the end of the test, the oxidation processes not yet stabilized, and would indicate that the cationic diffusion of the metallic species (chromium and iron) is precursory to the oxidation (anionic diffusion of oxygen).

Figure 32 – Comparison of crack structures

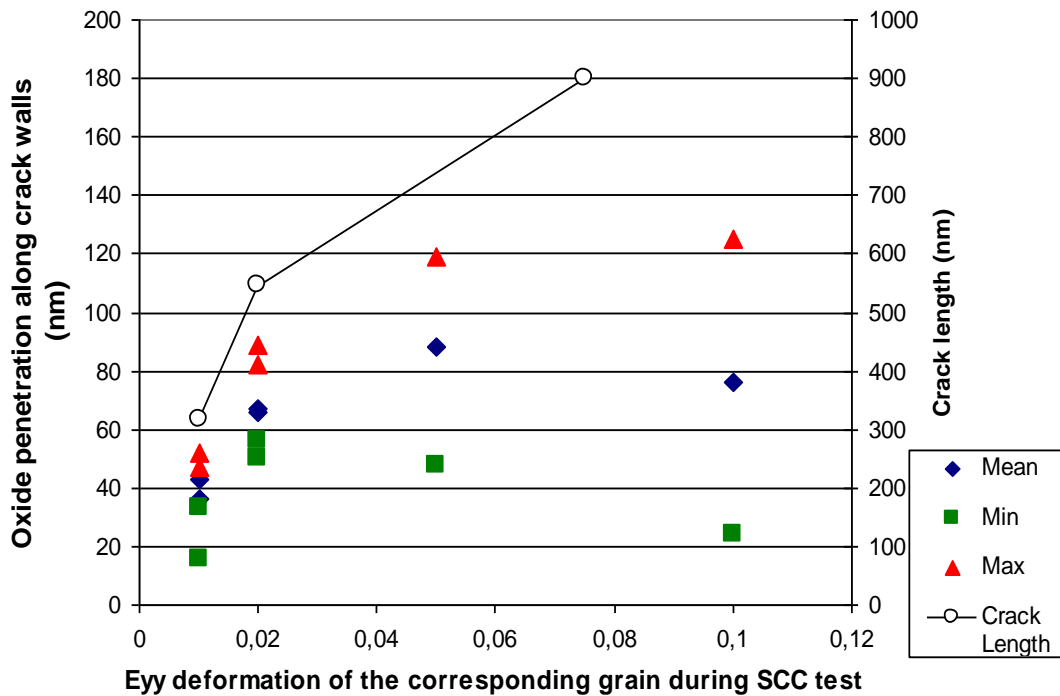
Figure 33 shows the evolution of oxidation depth along the crack walls and crack length as a function of local deformation during the test (second E_{yy}). Observations are consistent with the surface observations, indicating a deeper penetration in areas with higher levels of deformation. Crack length seems to be correlated to local deformation in a similar way. Again, the crack at site 1 stands out, as seen on the EFTEM image (**Figure 26**). At a higher level of deformation, it is the longest crack and highest maximum oxide penetration along the crack walls. However, as indicated above, closer to the tip, the oxide thickness decreases. This may indicate that the crack was still active at the end of the test, achieving a deeper penetration and passivity where the crack initiated and thinner penetration in later exposed surfaces after a propagation step. From this case, and assuming the other two cracks experienced only one cracking event, this would indicate that the typical intergranular cracking step is between 200 nm and 500 nm. This information is valuable for the general understanding of SCC mechanisms, as it defines an area where investigations about the cracking factors should be led, and sets a representative length scale for future mechanistic modeling of intergranular cracking.

Figure 33 – Oxidation of the crack walls and crack length as a function of deformation
