Coupled hydrogen and phosphorous induced initiation of internal cracks in a large 18MnNiMo5 component

Jean-Gabriel Sezgin, Cédric Bosch, Aurore Montouchet, Gilles Perrin, Andrej Atrens, Krzysztof Wolski

This study analyzed a crack in a scrapped 18MnNiMo5 80-tonne shell. The root cause of crack formation was the low fracture toughness caused by a combination of a high hydrogen content and phosphorous segregation, caused by an inappropriate heat treatment. Cracking initiated on MnS inclusion clusters enabled by hydrogen desorption at the MnS/matrix interfaces. Crack propagation was due to the internal hydrogen pressure causing the crack tip stress intensity factor to exceed the locally-reduced fracture toughness. This new hydrogen induced cracking (HIC) mechanism can be designated as Hydrogen Induced Localised Damage (HILD). Appropriate process controls can eliminate such defects.

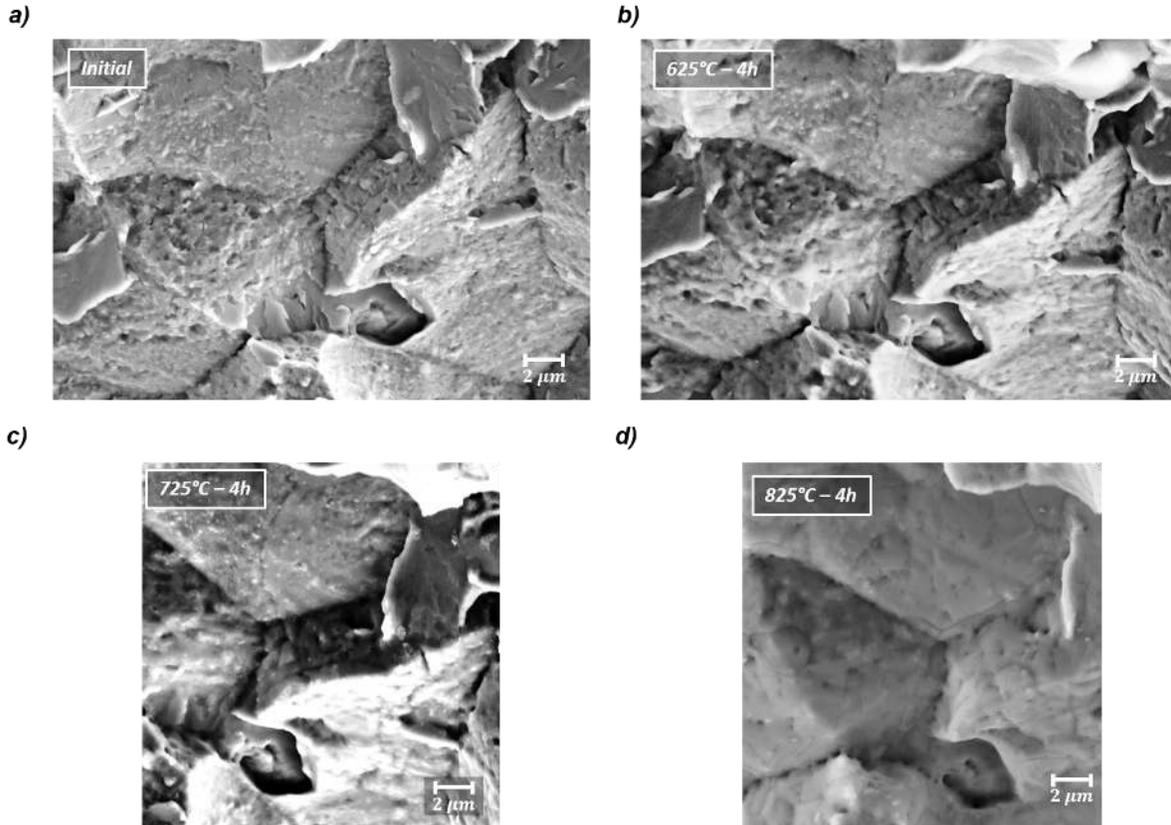
The progressive heat treatments from $625 \text{ }^\circ\text{C}$ to $825 \text{ }^\circ\text{C}$ were performed in three sequential steps, each followed by SEM fractographic observations. Figure 7 shows micrographs of the same area after each heat treatment. Fig. 7a) presents the initial reference condition, and (b,c,d) correspond to observations after $625 \text{ }^\circ\text{C}$, $725 \text{ }^\circ\text{C}$ and $825 \text{ }^\circ\text{C}$ heat treatments respectively. This figure shows the evolution of the morphology of the intergranular surface with the progressive smoothing of the grainy-texture typical of this type of fracture.

Figure 7 SEM observations of the morphological evolution of intergranular facets following progressive heating under UHV conditions. Four successive steps are represented: (a) initial reference condition, (b) 625 °C for 4 h, (c) 725 °C for 4 h, (d), 825 °C for 4 h.

After the heat treatment at 825 °C the smoothing is significant but less pronounced than that of the industrial crack from the component presented in Figure 5, especially 5c.

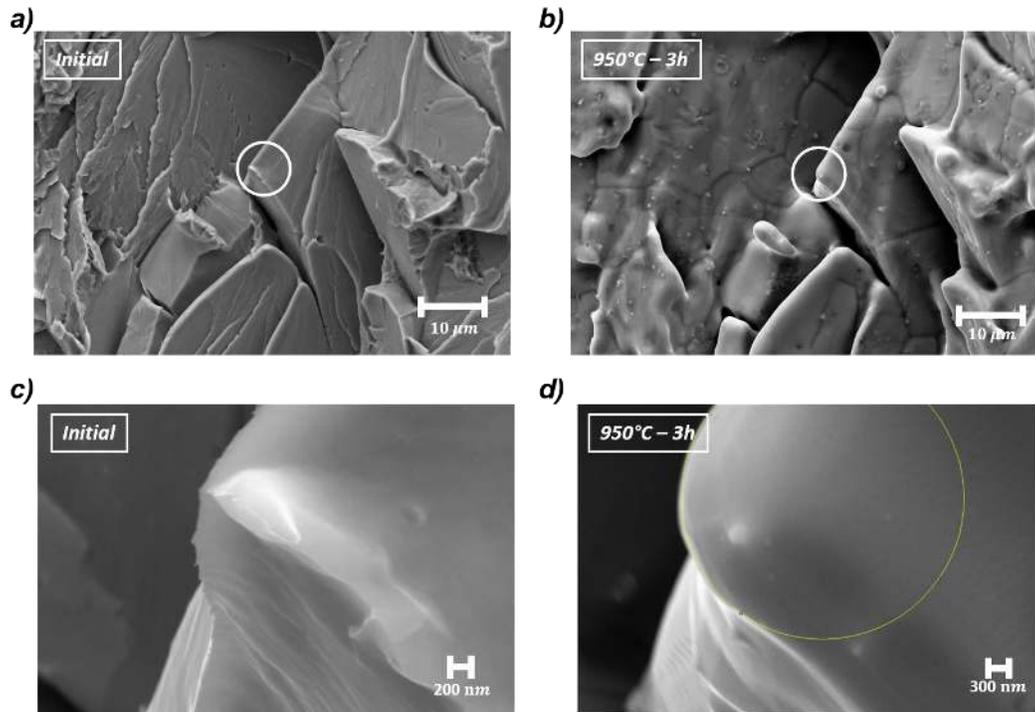
This heat treatment was aimed to reproduce the effect of the austenitisation heat treatment on the second specimen, which had a transgranular fracture surface. Figure 8 presents the fracture surface before (a) and after (b) this heat treatment at 950 °C for 3 hours. Figure 8a shows the pattern of sharp angularities, which are characteristic of this type of brittle fracture. In contrast, after the heat treatment, the surface was smoothed and not angular anymore. Moreover, the comparison of cleavage planes shows that river patterns had vanished following this heat treatment. The tiny thermal grooves might correspond to boundaries between packets of bainite. They can also indicate the emergence of prior austenite grain boundaries due to the heating above the A_{c1} temperature. Figure 8c) and (d) are magnifications of the initially sharp angle marked with a white circle. A comparison between these two micrographs can be quantitatively expressed by a local radius of curvature after heat treatment. This radius represented by a yellow circle on Figure 8d) was 900 nm, measured by an image processing technique. Figure 9 presents another area of the transgranular fracture surface before (a) and after heat treatment (b). The observed smoothing was similar to that presented in Figure 4b.

Figure 8 SEM micrographs of a transgranular facet before (a,c) and after (b,d) a 950 °C heat treatment under UHV conditions for 3 h. a) Transgranular fracture. b) Smoothed facet after exposure to 950 °C. c) Focus on the sharp angularity indicated in (a) before heat treatment. d) Focus of the sharp angularity indicated in (b) after heat treatment. The heat treatment has introduced a radius of curvature of 900 nm, which is represented on the micrograph by the yellow circle.

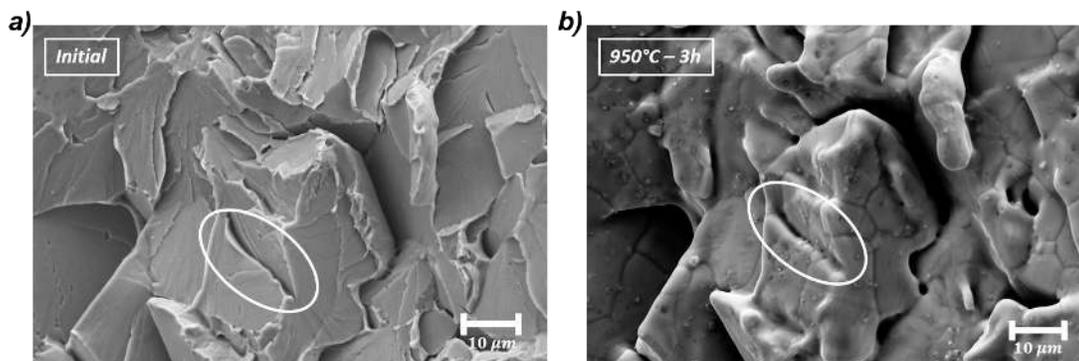
Figure 9 SEM micrographs of a transgranular facet before (a) and after (b) a 950 °C heat treatment in UHV condition for 3 h. a) Sharp crack tip indicated by an ellipse. b) Creation of bridges linking both sides of the crack tip especially in the thinnest areas

The observation of morphological evolution of the fracture surface as a function of temperature for the relatively short durations of 3 to 4 hours indicated a progressive smoothing of both intergranular and transgranular fracture surfaces. The highest temperature produced smoothing similar to that on the crack extracted from the industrial component. At this temperature the smoothing was so pronounced that microscopic features like the granny morphology on the individual intergranular facet or river lines on individual transgranular facet tended to disappear due to surface diffusion. These observations indicate that the initially brittle surface of the

industrial crack was exposed to the austenitisation temperature, and in particular to the second austenitisation heat treatment. Clearly, the cracks were formed before this austenitisation, during the unplanned slow cooling down to the room temperature or during the subsequent 1,5 months of storage.

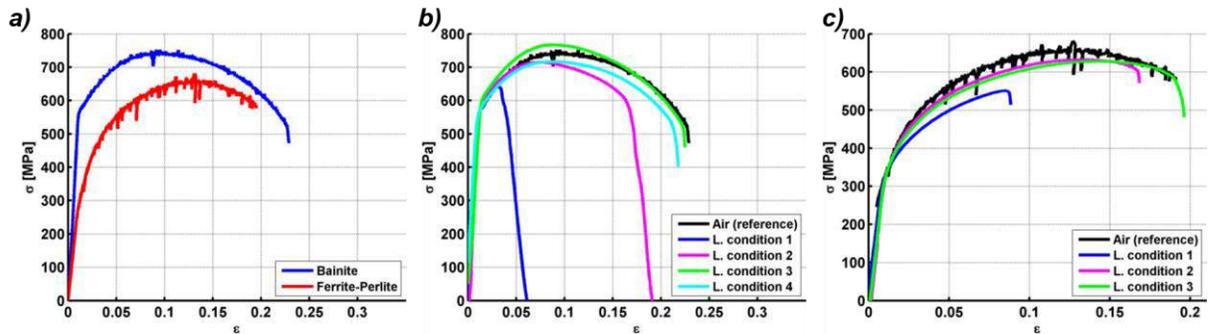
The results of the slow tensile tests are presented in Figure 10, Table 2 and Table 3. Figure 10a) presents the stress-strain curves for two reference specimens tested in air at room temperature. Both, exhibited ductile behavior: the specimen with the bainitic microstructure and the specimen with the ferrite-pearlitic microstructure. Figure 10b) presents the effect of hydrogen on the bainitic microstructure. The comparison with the air reference specimen indicates a progressive embrittlement as the severity of the charging condition is increased. Testing conditions 3 and 4 produced only a small effect of hydrogen on the mechanical behavior. Loading with charging conditions 1 and 2 significantly changed the stress-strain curves. There was a significant decrease of strength and reduced plasticity, especially for condition 1. The load decrease was compatible with centripetal crack propagation at the UTS across the round section until specimen failure. Figure 10c) presents the results for the ferrite-perlite microstructure. These stress-strain curves lead to similar conclusions. The intensity of HE increased with the testing severity. The presence of hydrogen mainly decreased plasticity. A comparison of Figure 10b) and Figure 10c) indicates that the hydrogen sensitivity of the bainitic microstructure was significantly higher.

Figure 10 Tensile stress-strain curves for: (a) both bainite and ferrite-perlite microstructures in air at 10^{-6} s^{-1} , (b) bainitic microstructure under different cathodic charging conditions at $5.0 \cdot 10^{-7} \text{ s}^{-1}$, and (c) ferrite-perlite microstructure under different cathodic charging conditions at $5.0 \cdot 10^{-7} \text{ s}^{-1}$

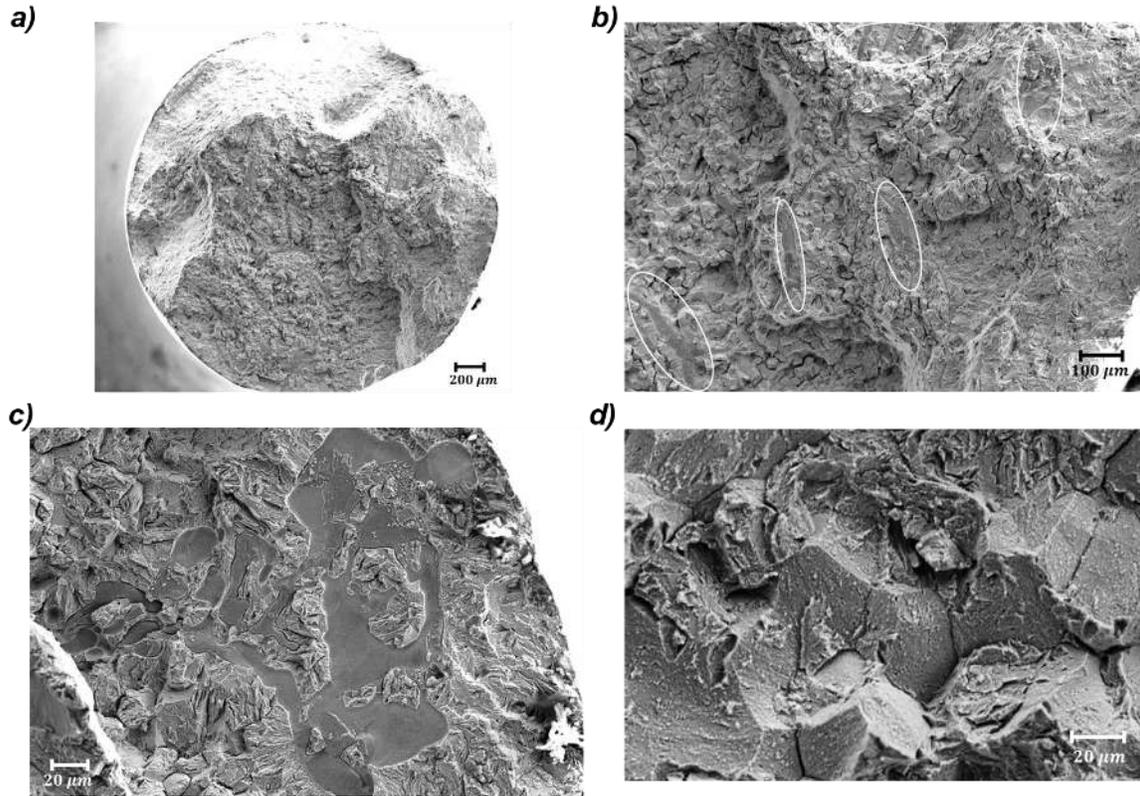
Figure 11 presents the fracture surface corresponding to the specimen with the bainitic microstructure and tested under condition 1. Figure 11a) presents an overview of the fracture surface. The fracture surface indicates crack initiation at the specimen surface at the bottom of the figure, and crack propagation towards the center of the specimen, followed by final fracture. The reduction of area and almost no necking indicate a macroscopically-brittle fracture of the specimen. The fact that there was necking indicated that the hydrogen induced cracking occurred at or after the ultimate tensile strength. This behavior explains the stress-strain curve from Figure 10b). Detailed observation revealed an abundance of MnS clusters as indicated in Figure 11b). This micrograph also indicates the presence of some ductility, which confirms the assumption of a curve governed by the centripetal crack propagation. This indicates that the brittle fracture occurred first, inducing a stress drop in this strain-controlled SSRT. This effect was followed by a subsequent failure of ductile ligaments. The brittle areas were mostly transgranular but Figure 11c) shows some intergranular regions located nearby MnS. This fact is emphasized in Figure 11d).

Figure 11 Fracture observation of the bainitic tensile specimen under the first hydrogen loading condition a) global view of the fracture surface, b) presence of elongated MnS inclusions enhancing HE contained in the white elliptic marks c) mixed transgranular-intergranular brittle fracture nearby MnS inclusions (dark smooth surfaces) with some ductile areas, and d) magnification of an intergranular fracture area, located close to MnS inclusions.

where r is the inner radius (at the notch) and R is the outer radius of the specimen. Figure 11a) shows two concentric areas. Assuming that the failure occurred in two steps, the peripheral surface crack can be considered as a pre-crack and the inner section as equivalent to the failure surface in a notched toughness test. The peak load, the average outer radius and the average crack length were measured as 4.58 kN, 1.33 mm and 467 μm respectively. The resulting fracture toughness under cathodic charging condition was estimated to be 19 $\text{MPa}\cdot\text{m}^{1/2}$. This coarsely approximated value can be used to determine the expected order of magnitude of the reduced toughness for the dimensioning of the CT specimen for the measurement of fracture toughness.

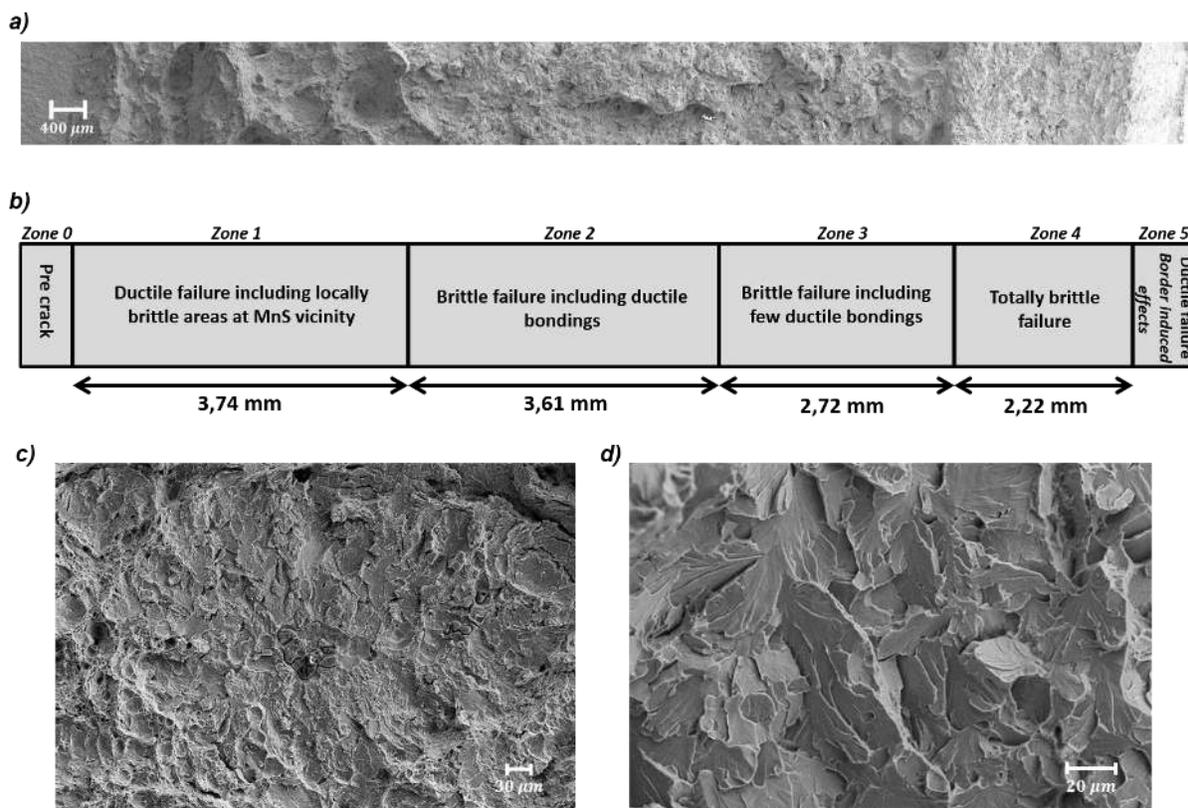
Figure 12 presents different aspects of the resulting fracture surface. Figure 12a) presents a global view. At this magnification, a progressive transition from ductile to brittle failure suggests a heterogeneous effect of hydrogen. This progression has been schematized in Figure 12b) which identifies several areas. Near the pre-crack in zone 0, the failure was mainly ductile with some embrittled areas located near MnS inclusions. The fracture path changed to a brittle mode in zones 2-4. These zones are characterized by the continuous reduction of ductility (e.g. ligaments) with increasing crack length. Figure 12c) presents a micrograph focusing on an embrittled area located in the vicinity of the MnS-inclusion in zone 2. Figure 12d) presents a micrograph focused on a representative area of zone 4. This zone was fully brittle transgranular with no trace of ductility.

Figure 12 Fracture surface obtained after a fracture toughness test under hydrogen charging conditions at $-1200 \text{ mV}_{\text{SCE}}$ in 30 g L^{-1} NaCl for 96 h. a) Overview SEM macrograph of the fracture surface. b) Schematic of the different areas on this fracture surface. c) Focus on an elliptic brittle area surrounding several MnS inclusions in the zone 2. d) Fully brittle fracture in zone 4.

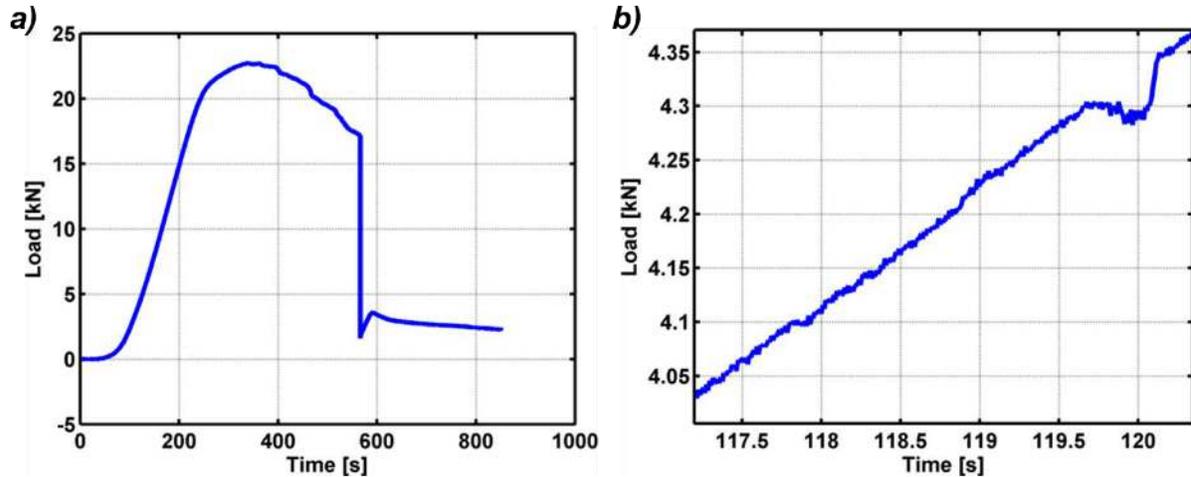
Figure 13a) presents the loading curve for this measurement. The overall shape of the curve indicates load increase up to a maximum of 23 kN followed by the progressive load decrease down to approximately 17 kN, whereupon there was a steep load drop. The critical event happened during the load increase. Figure 13b) presents a magnification of the ascending part of the loading curve. There was a slight load drop during the test, indicating the damage of the material within the elastic region of the curve. The amplitude of the drop was significantly greater than the acquisition noise. In addition, the load recovery led to a load curve in continuity with the initial slope.

This damage, that had occurred at 4,3 kN, was linked to the highly heterogeneous microstructure of this steel, and was attributed to micro-fracture of such a heterogeneous area, situated within the ductile region in zone 1. In fact, it is worth emphasising that the 18MnNiMo5 steel is a highly heterogeneous bainitic steel containing ghost lines and microsegregated zones, since it is obtained from a very large ingot. While the nominal toughness of this alloy is of the order of 200 MPa.m^{1/2}, individual values well below 100 MPa.m^{1/2} are measured. They reflect intrinsic material heterogeneities, namely microsegregations, which are of submillimeter size, therefore much smaller than the CT fracture surface. Under hydrogen charging, much lower values of fracture toughness are expected due to the hydrogen embrittlement phenomenon.

The fracture toughness evaluated from the load drop at 4.3 kN was 18 MPa.m^{1/2}. This measurement provides an estimation of the reduced local fracture toughness since the plain strain conditions are strictly respected for this load. This value of 18 MPa.m^{1/2} reflects hydrogen effect on the local fracture toughness of a microsegregated area, and has to be considered as an estimate because significant variations can be anticipated depending on the actual position of a microsegregated areas with respect to the crack tip position.

Figure 13 Loading curves for the toughness test using a pre-cracked CT specimen under hydrogen charging conditions. a) Overall load-time curve. b) Focus on the load drop at around 4.3 kN. This load drop is attributed to the embrittled areas near MnS inclusion in Zone 1 and 2, and can therefore provide a quantitative value for the fracture toughness in the presence of hydrogen of a microsegregated area.
