Coupled hydrogen and phosphorous induced initiation of internal cracks in a large 18MnNiMo5 component

This study analyzed a crack in a scrapped 18MnNiMo5 80-tonne shell. The root cause of crack formation was the low fracture toughness caused by a combination of a high hydrogen content and phosphorous segregation, caused by an inappropriate heat treatment. Cracking initiated on MnS inclusion clusters enabled by hydrogen desorption at the MnS/matrix interfaces. Crack propagation was due to the internal hydrogen pressure causing the crack tip stress intensity factor to exceed the locally-reduced fracture toughness. This new hydrogen induced cracking (HIC) mechanism can be designated as Hydrogen Induced Localised Damage (HILD). Appropriate process controls can eliminate such defects.

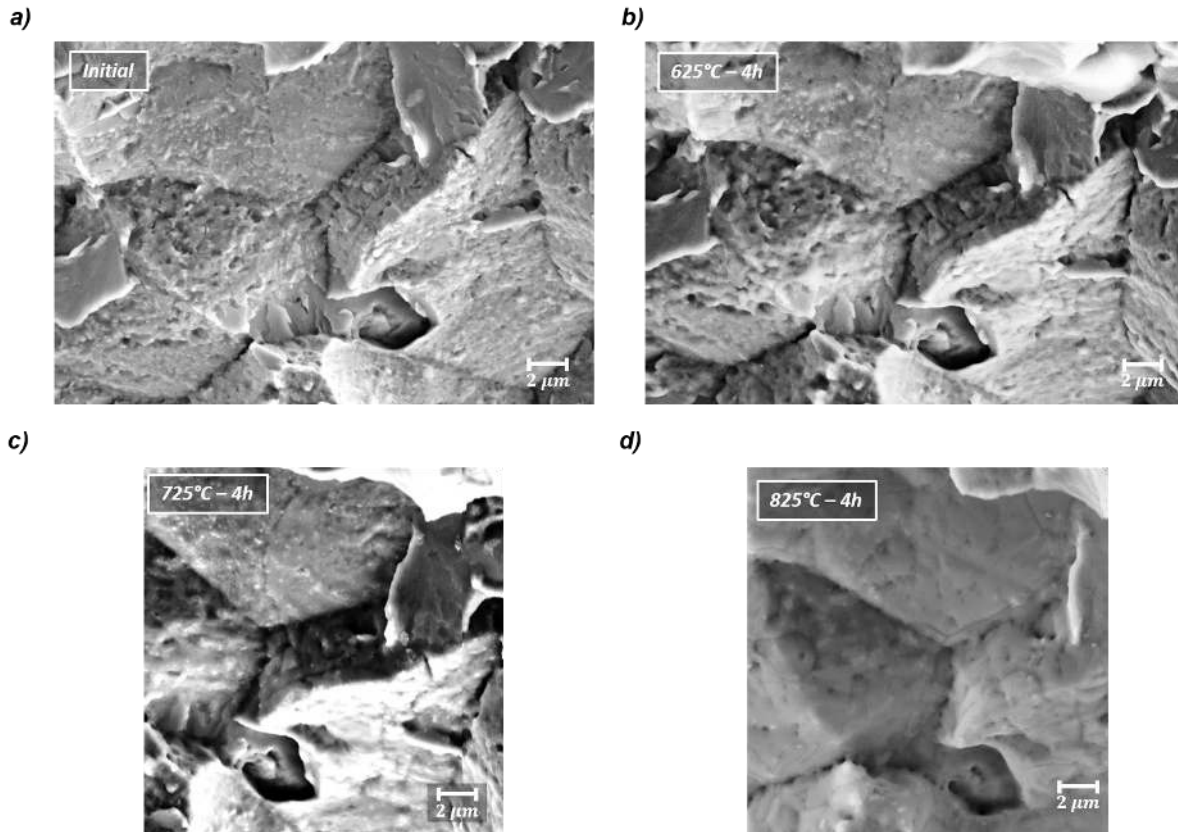
The progressive heat treatments from $625 \text{ }^{\circ}\text{C}$ to $825 \text{ }^{\circ}\text{C}$ were performed in three sequential steps, each followed by SEM fractographic observations. Figure 7 shows micrographs of the same area after each heat treatment. Fig. 7a) presents the initial reference condition, and (b,c,d) correspond to observations after $625 \text{ }^{\circ}\text{C}$, $725 \text{ }^{\circ}\text{C}$ and $825 \text{ }^{\circ}\text{C}$ heat treatments respectively. This figure shows the evolution of the morphology of the intergranular surface with the progressive smoothing of the grainy-texture typical of this type of fracture.

Figure 7 SEM observations of the morphological evolution of intergranular facets following progressive heating under UHV conditions. Four successive steps are represented: (a) initial reference condition, (b) 625 °C for 4 h, (c) 725 °C for 4 h, (d), 825 °C for 4 h.

After the heat treatment at 825 °C the smoothing is significant but less pronounced than that of the industrial crack from the component presented in Figure 5, especially 5c.

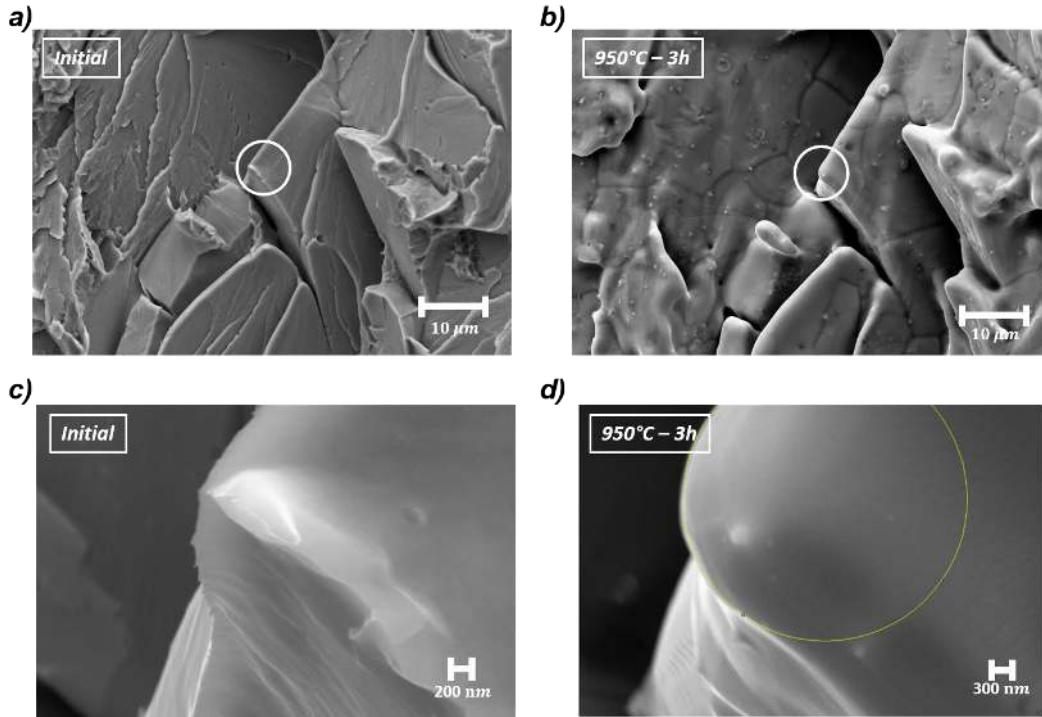
This heat treatment was aimed to reproduce the effect of the austenitisation heat treatment on the second specimen, which had a transgranular fracture surface. Figure 8 presents the fracture surface before (a) and after (b) this heat treatment at 950 °C for 3 hours. Figure 8a shows the pattern of sharp angularities, which are characteristic of this type of brittle fracture. In contrast, after the heat treatment, the surface was smoothed and not angular anymore. Moreover, the comparison of cleavage planes shows that river patterns had vanished following this heat treatment. The tiny thermal grooves might correspond to boundaries between packets of bainite. They can also indicate the emergence of prior austenite grain boundaries due to the heating above the A_{c1} temperature. Figure 8c) and (d) are magnifications of the initially sharp angle marked with a white circle. A comparison between these two micrographs can be quantitatively expressed by a local radius of curvature after heat treatment. This radius represented by a yellow circle on Figure 8d) was 900 nm, measured by an image processing technique. Figure 9 presents another area of the transgranular fracture surface before (a) and after heat treatment (b). The observed smoothing was similar to that presented in Figure 4b.

Figure 8 SEM micrographs of a transgranular facet before (a,c) and after (b,d) a 950 °C heat treatment under UHV conditions for 3 h. a) Transgranular fracture. b) Smoothed facet after exposure to 950 °C. c) Focus on the sharp angularity indicated in (a) before heat treatment. d) Focus of the sharp angularity indicated in (b) after heat treatment. The heat treatment has introduced a radius of curvature of 900 nm, which is represented on the micrograph by the yellow circle.

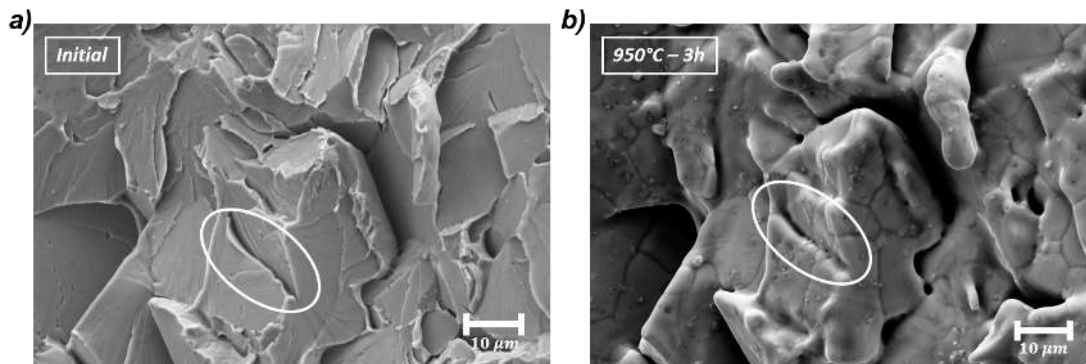
Figure 9 SEM micrographs of a transgranular facet before (a) and after (b) a 950 °C heat treatment in UHV condition for 3 h. a) Sharp crack tip indicated by an ellipse. b) Creation of bridges linking both sides of the crack tip especially in the thinnest areas

The observation of morphological evolution of the fracture surface as a function of temperature for the relatively short durations of 3 to 4 hours indicated a progressive smoothing of both intergranular and transgranular fracture surfaces. The highest temperature produced smoothing similar to that on the crack extracted from the industrial component. At this temperature the smoothing was so pronounced that microscopic features like the granny morphology on the individual intergranular facet or river lines on individual transgranular facet tended to disappear due to surface diffusion. These observations indicate that the initially brittle surface of the

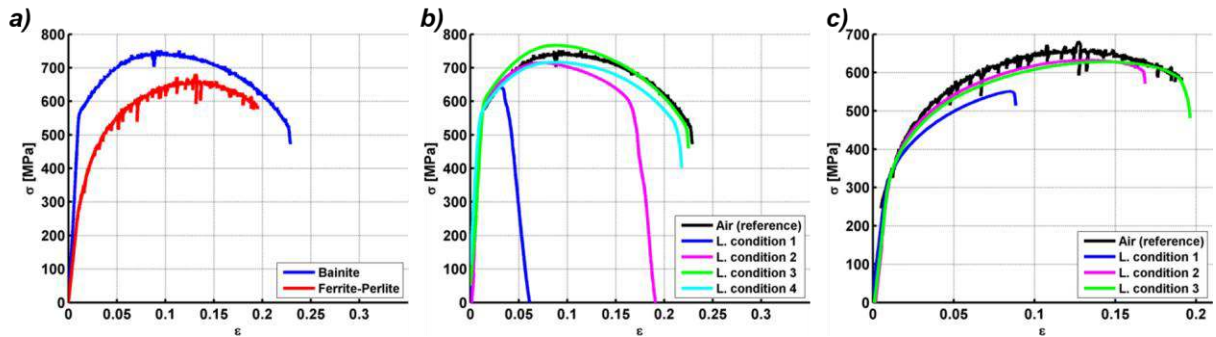
The results of the slow tensile tests are presented in Figure 10, Table 2 and Table 3. Figure 10a) presents the stress-strain curves for two reference specimens tested in air at room temperature. Both, exhibited ductile behavior: the specimen with the bainitic microstructure and the specimen with the ferrite-pearlitic microstructure. Figure 10b) presents the effect of hydrogen on the bainitic microstructure. The comparison with the air reference specimen indicates a progressive embrittlement as the severity of the charging condition is increased. Testing conditions 3 and 4 produced only a small effect of hydrogen on the mechanical behavior. Loading with charging conditions 1 and 2 significantly changed the stress-strain curves. There was a significant decrease of strength and reduced plasticity, especially for condition 1. The load decrease was compatible with centripetal crack propagation at the UTS across the round section until specimen failure. Figure 10c) presents the results for the ferrite-perlite microstructure. These stress-strain curves lead to similar conclusions. The intensity of HE increased with the testing severity. The presence of hydrogen mainly decreased plasticity. A comparison of Figure 10b) and Figure 10c) indicates that the hydrogen sensitivity of the bainitic microstructure was significantly higher.

Figure 10 Tensile stress-strain curves for: (a) both bainite and ferrite-perlite microstructures in air at 10^{-6} s^{-1} , (b) bainitic microstructure under different cathodic charging conditions at $5.0 \cdot 10^{-7} \text{ s}^{-1}$, and (c) ferrite-perlite microstructure under different cathodic charging conditions at $5.0 \cdot 10^{-7} \text{ s}^{-1}$

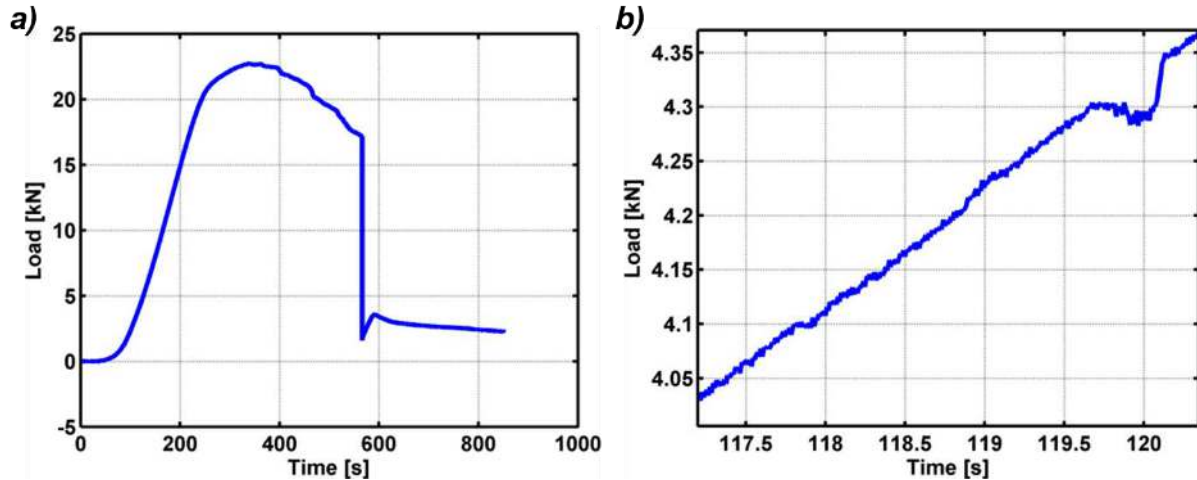
Figure 13a) presents the loading curve for this measurement. The overall shape of the curve indicates load increase up to a maximum of 23 kN followed by the progressive load decrease down to approximately 17 kN, whereupon there was a steep load drop. The critical event happened during the load increase. Figure 13b) presents a magnification of the ascending part of the loading curve. There was a slight load drop during the test, indicating the damage of the material within the elastic region of the curve. The amplitude of the drop was significantly greater than the acquisition noise. In addition, the load recovery led to a load curve in continuity with the initial slope.

The fracture toughness corresponding to the peak load of 23 kN was 95 MPa.m^{1/2} but this value was invalid since the plain strain conditions were not satisfied at this load for this specimen. This measurement cannot be interpreted.

The fracture toughness evaluated from the load drop at 4.3 kN was 18 MPa.m^{1/2}. This measurement provides an estimation of the reduced local fracture toughness since the plain strain conditions are strictly respected for this load. This value of 18 MPa.m^{1/2} reflects hydrogen effect on the local fracture toughness of a microsegregated area, and has to be considered as an estimate because significant variations can be anticipated depending on the actual position of a microsegregated areas with respect to the crack tip position.

Figure 13 Loading curves for the toughness test using a pre-cracked CT specimen under hydrogen charging conditions. a) Overall load-time curve. b) Focus on the load drop at around 4.3 kN. This load drop is attributed to the embrittled areas near MnS inclusion in Zone 1 and 2, and can therefore provide a quantitative value for the fracture toughness in the presence of hydrogen of a microsegregated area.
