## Effect of the Chemical Composition of Building Materials on Algal Biofouling

Philippe Grosseau, Estelle Dalod, Alexandre Govin, Christine Lors, René Guyonnet, et al.. Effect of the Chemical Composition of Building Materials on Algal Biofouling. Concrete 2015 / RILEM Week - 27th Biennial National Conference of the Concrete Institute of Australia in conjunction with the 69th RILEM Week, the Concrete Institute of Australia; RILEM, Aug 2015, Melbourne, Australia. pp.735 à 744. emse-01206843

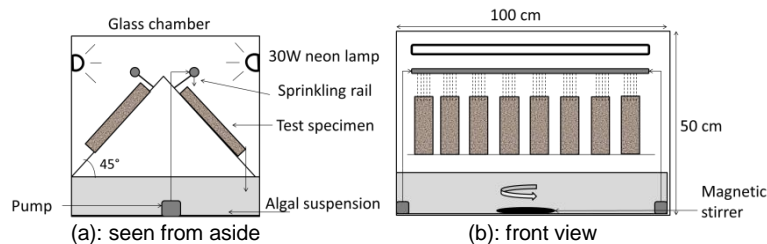
The system consisted of a glass chamber of dimensions 100x50x50 cm in which were settled two stainless steel supports inclined at 45 ° (Figure 1). The mortar samples were exposed to the same conditions of light ( $20\mu\text{mol}/\text{m}^2/\text{s}$  PPF, photoperiods of 12 hours) and temperature (20°C) as for the algal growth. The temperature was maintained with a thermoregulator. The box was filled with 50L of microalgal suspension, (concentration of 4mg/L dry mass) which was pumped and sprinkled on the top of mortar samples. The watering was made by means of a full holes banister of 2 mm in diameter, every 1 cm. The flow was set to  $26 \pm 1$  L/h. The sprinkling was carried out for 90 minutes every 12 hours and enabled to reproduce the phenomenon of colonization of a facade: microalgae were transported by the solution and had the possibility of hanging on and of adhering to the surface according to the characteristics of the mortar.

Figure 1. Laboratory bench for the colonization of mortars by streaming of algal suspension

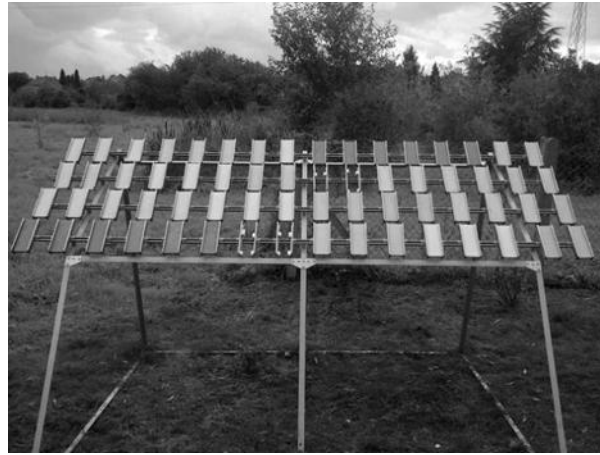
The in situ bench is set up at the "Ecole Nationale Supérieure des Mines de Douai" situated in Douai (North of France). The bench test on which are exposed 60 samples is constituted by a stainless steel structure (Figure 2). The angle of inclination is fixed to 45° which allows exposing samples to the weather conditions (period of sunshine, streaming, gusts of wind). Rows of samples are situated at least 1 meter above ground level, to avoid spatters phenomena. Samples are arranged so that the flow from one sample cannot contaminate the sample situated below and are spaced out by 5 cm to avoid contaminations. The site of exposure is a flat ground, distant from the traffic and close to some trees (situated at about 15 m from the bench)

**Figure 2. In-Situ bench for the colonization of mortars**

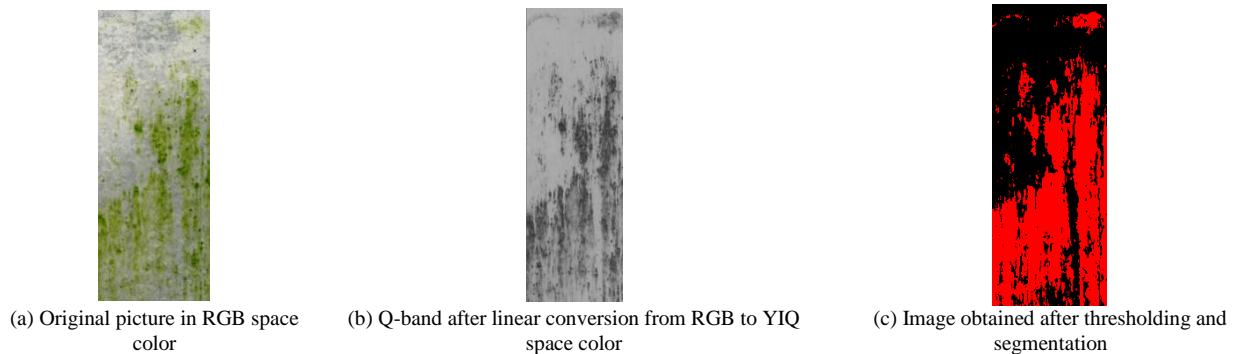
The Q channel was used to quantify the number of colonized pixels after thresholding and segmentation. The colonization rate was given by the ratio of colonized area to the total surface. The different steps of image analysis are detailed on Figure 3. After segmentation the binary image represents in red the fouled area and in black the unfouled one.

**Figure 3. Example of image analysis of a specimen after 9 days test**

The biodeterioration intensity was measured by image analysis. Thanks to an office scanner, the surface of sample mortars was digitized at different times. These images were then treated with the software Aphélon<sup>®</sup> which calculates a covering rate (noted  $X(t)$ ) of samples by microalgae (13). The initial RGB color space was converted in YIQ color space in order to identify easily the green algae on mortars.

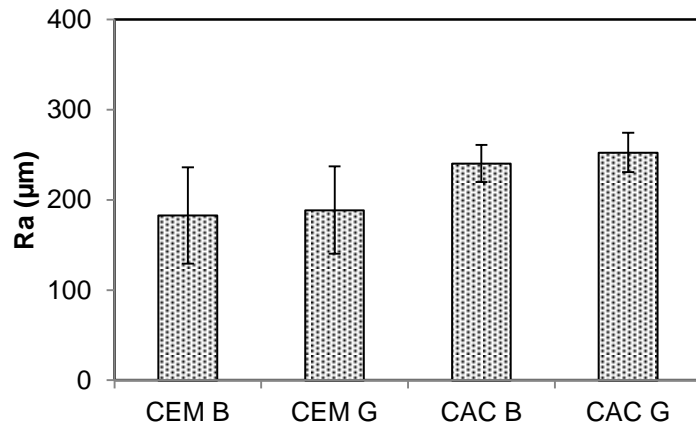
Results represented on Figures 4, 5 and 6 show that roughness, surface pH and porosity are not significantly different for all samples, around a value of about  $220 \mu\text{m}$  for roughness, 8.8 for surface pH and 14% for the porosity. This is an important result since it was already proven that these characteristics have a strong influence on the kinetics of biocolonization of mortars (4,5,9,12,13,14). As the physical characteristics of presently studied mortars are similar, we will thus be able to compare the effect of the chemical composition on the resistance to biofouling.

**Figure 4. Roughness of studied materials**

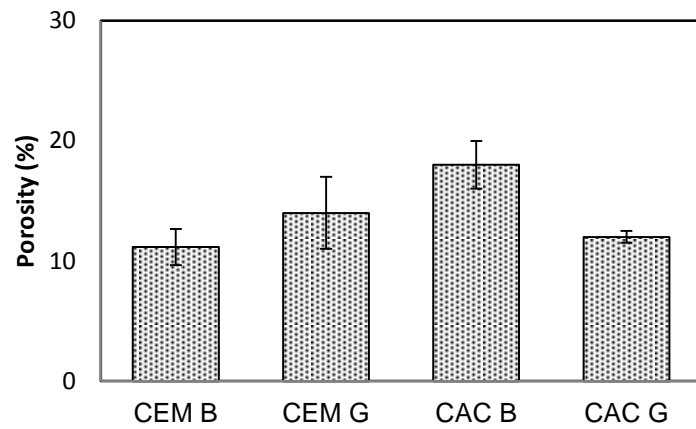
**Figure 5. Porosities of studied materials**

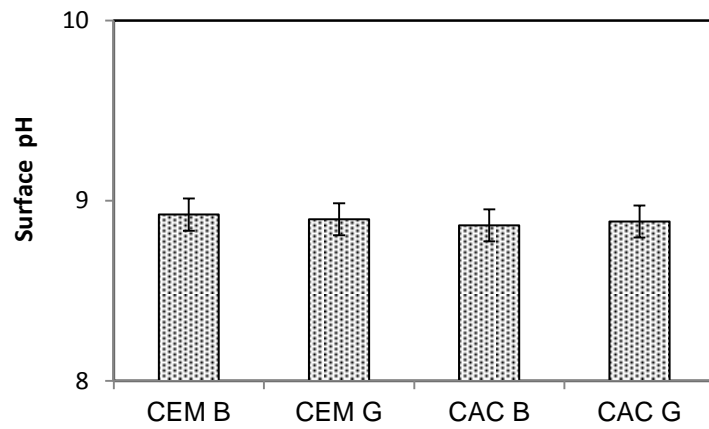
**Figure 6. Surface pH of studied materials**

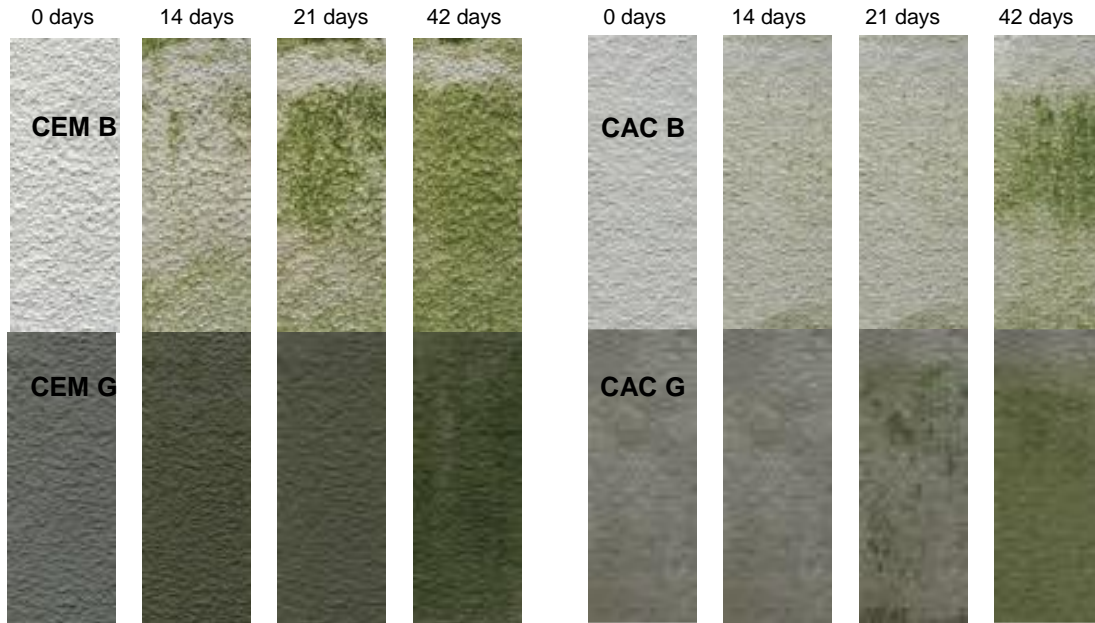
The pictures of Figure 7 show the evolution of the surface of the specimens during the test period for Portland cement mortars and CAC mortars and we can thus notice that CAC based mortars were much less quickly colonized than Portland cement based mortars.

Figure 7. Evolution of the biocolonisation of the samples during accelerated laboratory test

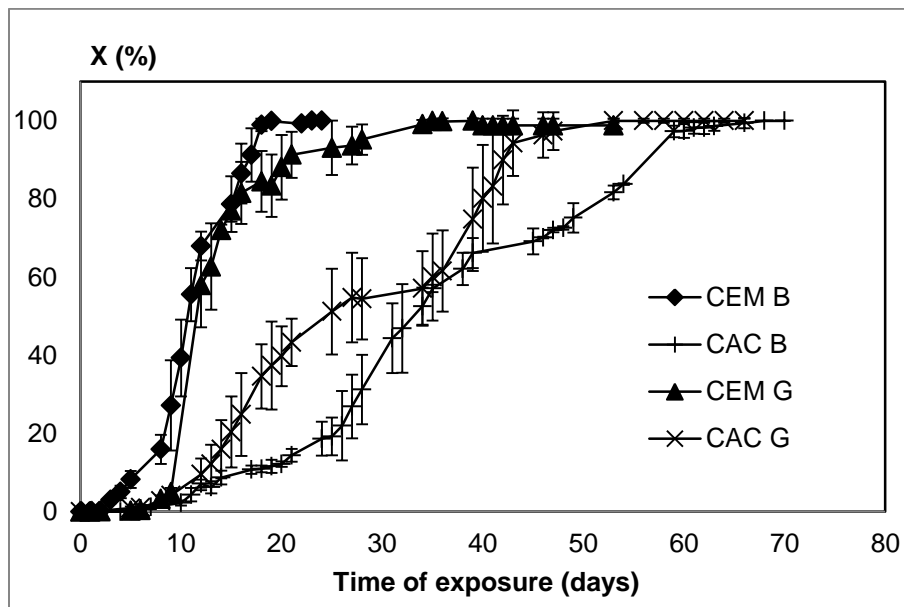
This phenomenon is fully confirmed by the evolution of the colonization rates of the specimens which is shown on Figure 8. The colonization of Portland cement based mortars both started earlier and was completed in a shorter time than the colonization of CAC based mortars.

Figure 8. Evolution of the fraction of colonized area during accelerated laboratory test

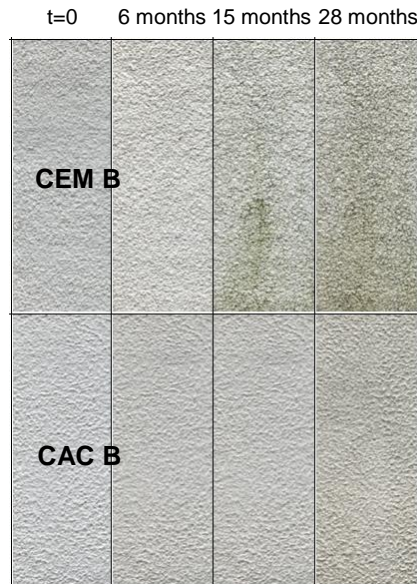
This part of the work was realised only with white mortars CEM B and CAC B. The samples were exposed from March 2012, at the beginning of spring. In a similar manner to what happened in laboratory tests, we can again notice that mortars containing CAC cement were more slowly colonized than the mortars which contain Portland cement (Figures 9 and 10).

Figure 9. Evolution of the biocolonisation of the samples during outdoor exposition

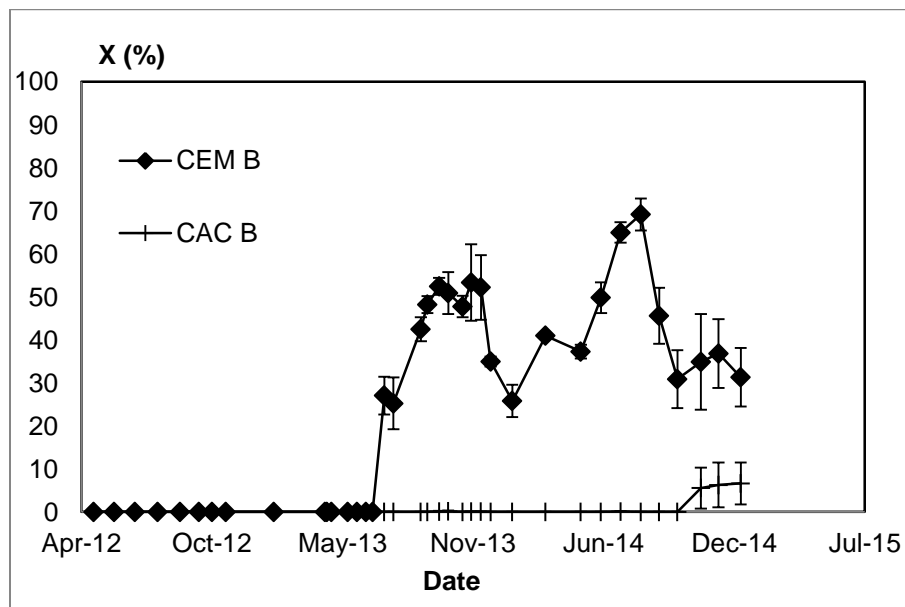
On Figure 10, one can notice a decrease of the colonization rate after about 550 days and 900 days of exposure. This phenomenon was due to winter conditions which implied a detachment of algae from the material.

Figure 10. Evolution of the fraction of colonized area during outdoor exposition

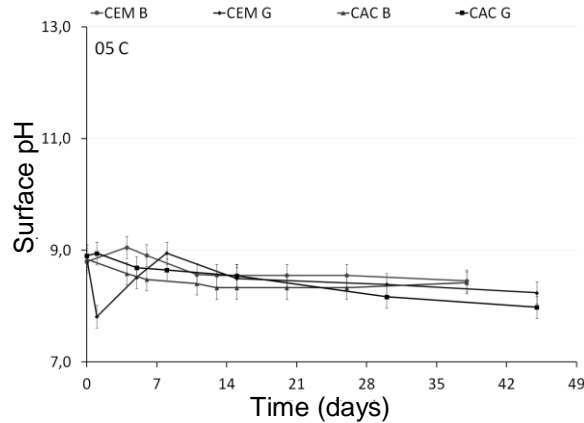
In order to verify that the observed phenomena were not due to a difference in the alkalinity of the studied mortars, we followed the evolution of surface pH of the samples and of the pH of the algal suspension all along the laboratory test. The results are shown in Figures 11 and 12. It is quite clear that there are no significant differences between the different materials tested, which is of course consistent with the fact that all samples are carbonated.

Figure 11. Evolution of the surface pH of samples during laboratory test

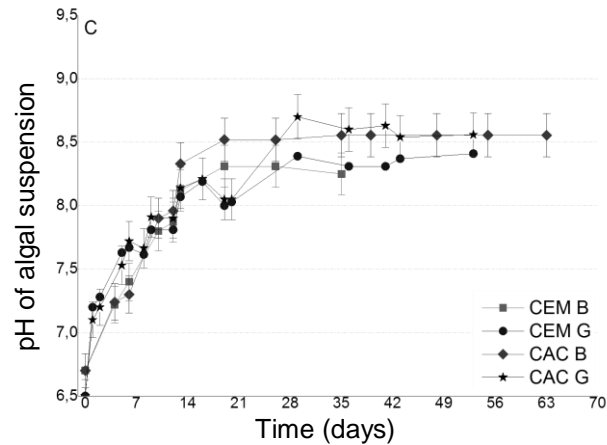
Figure 12. Evolution of the pH of algal suspension during laboratory test
