Effect of the Chemical Composition of Building Materials on Algal Biofouling

Philippe Grosseau, Estelle Dalod, Alexandre Govin, Christine Lors, René Guyonnet, Denis Damidot

Philippe Grosseau, Estelle Dalod, Alexandre Govin, Christine Lors, René Guyonnet, et al.. Effect of the Chemical Composition of Building Materials on Algal Biofouling. Jay Sanjayan; Kwesi Sagoe-Crentsil. Concrete 2015 / RILEM Week - 27th Biennial National Conference of the Concrete Institute of Australia in conjunction with the 69th RILEM Week, Aug 2015, Melbourne, Australia. the Concrete Institute of Australia, Proceedings of the 27th Biennial National Conference Concrete Institute of Australia in conjunction with the 69th RILEM Week - ISBN: 978-1-943847-70-9, pp.735 à 744, 2015. <emse-01206843>

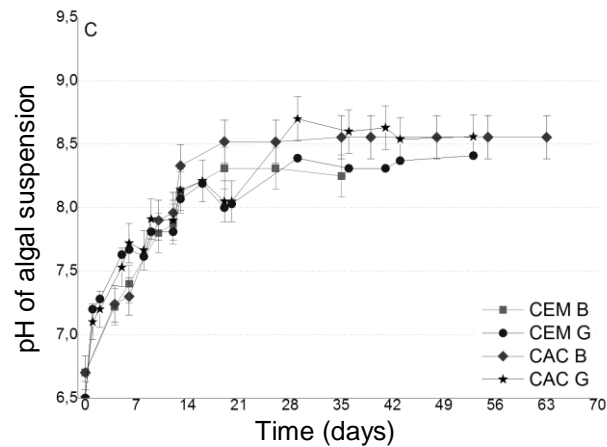
In order to verify that the observed phenomena were not due to a difference in the alkalinity of the studied mortars, we followed the evolution of surface pH of the samples and of the pH of the algal suspension all along the laboratory test. The results are shown in Figures 11 and 12. It is quite clear that there are no significant differences between the different materials tested, which is of course consistent with the fact that all samples are carbonated.

Figure 12. Evolution of the pH of algal suspension during laboratory test
