Effect of the Chemical Composition of Building Materials on Algal Biofouling

Philippe Grosseau, Estelle Dalod, Alexandre Govin, Christine Lors, René Guyonnet, Denis Damidot

Philippe Grosseau, Estelle Dalod, Alexandre Govin, Christine Lors, René Guyonnet, et al.. Effect of the Chemical Composition of Building Materials on Algal Biofouling. Concrete 2015 / RILEM Week - 27th Biennial National Conference of the Concrete Institute of Australia in conjunction with the 69th RILEM Week, the Concrete Institute of Australia; RILEM, Aug 2015, Melbourne, Australia. pp.735 à 744. emse-01206843

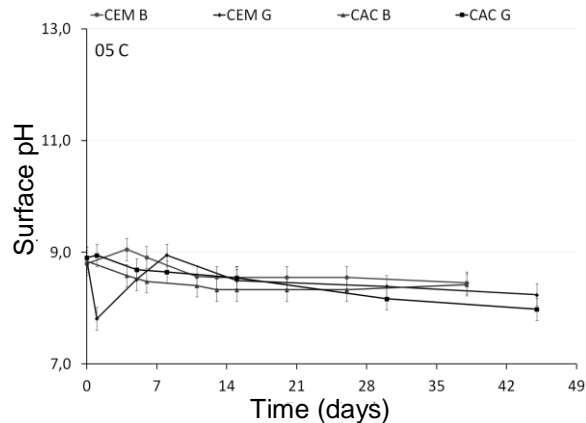
In order to verify that the observed phenomena were not due to a difference in the alkalinity of the studied mortars, we followed the evolution of surface pH of the samples and of the pH of the algal suspension all along the laboratory test. The results are shown in Figures 11 and 12. It is quite clear that there are no significant differences between the different materials tested, which is of course consistent with the fact that all samples are carbonated.

Figure 11. Evolution of the surface pH of samples during laboratory test

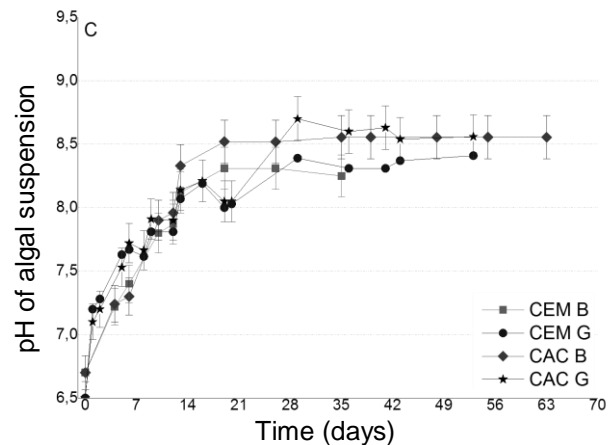
Figure 12. Evolution of the pH of algal suspension during laboratory test
