Effect of the Chemical Composition of Building Materials on Algal Biofouling

Philippe Grosseau, Estelle Dalod, Alexandre Govin, Christine Lors, René Guyonnet, Denis Damidot

Keywords: biodeterioration, algae, mortars, Portland cement, Calcium Aluminate Cement.

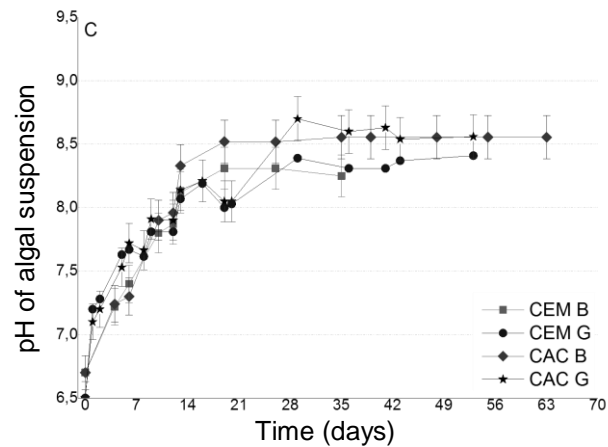
In order to verify that the observed phenomena were not due to a difference in the alkalinity of the studied mortars, we followed the evolution of surface pH of the samples and of the pH of the algal suspension all along the laboratory test. The results are shown in Figures 11 and 12. It is quite clear that there are no significant differences between the different materials tested, which is of course consistent with the fact that all samples are carbonated.

Figure 12. Evolution of the pH of algal suspension during laboratory test
