Effect of the Chemical Composition of Building Materials on Algal Biofouling

Philippe Grosseau, Estelle Dalod, Alexandre Govin, Christine Lors, René Guyonnet, Denis Damidot

Philippe Grosseau, Estelle Dalod, Alexandre Govin, Christine Lors, René Guyonnet, et al.. Effect of the Chemical Composition of Building Materials on Algal Biofouling. Concrete 2015 / RILEM Week - 27th Biennial National Conference of the Concrete Institute of Australia in conjunction with the 69th RILEM Week, the Concrete Institute of Australia; RILEM, Aug 2015, Melbourne, Australia. pp.735 à 744. emse-01206843

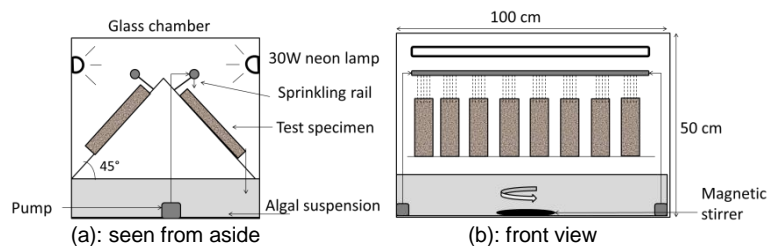
The system consisted of a glass chamber of dimensions 100x50x50 cm in which were settled two stainless steel supports inclined at 45 ° (Figure 1). The mortar samples were exposed to the same conditions of light ($20\mu\text{mol}/\text{m}^2/\text{s}$ PPF, photoperiods of 12 hours) and temperature (20°C) as for the algal growth. The temperature was maintained with a thermoregulator. The box was filled with 50L of microalgal suspension, (concentration of 4mg/L dry mass) which was pumped and sprinkled on the top of mortar samples. The watering was made by means of a full holes banister of 2 mm in diameter, every 1 cm. The flow was set to 26 ± 1 L/h. The sprinkling was carried out for 90 minutes every 12 hours and enabled to reproduce the phenomenon of colonization of a facade: microalgae were transported by the solution and had the possibility of hanging on and of adhering to the surface according to the characteristics of the mortar.

Figure 1. Laboratory bench for the colonization of mortars by streaming of algal suspension

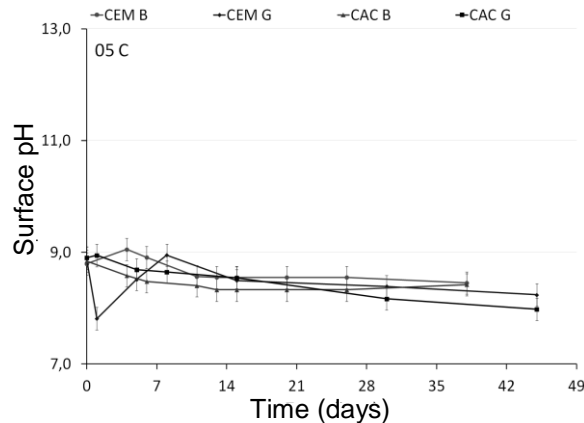
In order to verify that the observed phenomena were not due to a difference in the alkalinity of the studied mortars, we followed the evolution of surface pH of the samples and of the pH of the algal suspension all along the laboratory test. The results are shown in Figures 11 and 12. It is quite clear that there are no significant differences between the different materials tested, which is of course consistent with the fact that all samples are carbonated.

Figure 11. Evolution of the surface pH of samples during laboratory test

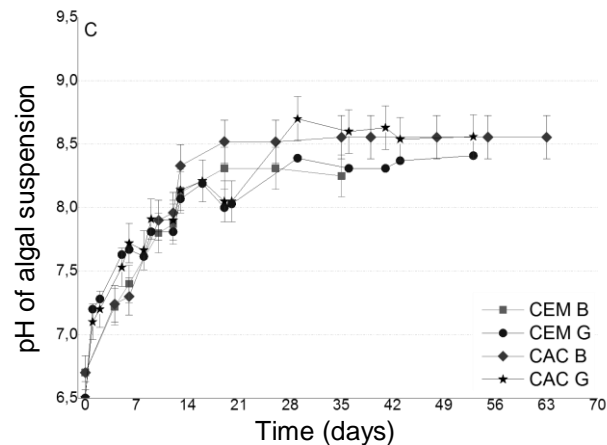
Figure 12. Evolution of the pH of algal suspension during laboratory test
