## Effect of hydrogen content in natural gas blend on the mechanical properties of a L485-MB low-alloyed steel

Hamza Ez-Zaki, Frédéric Christien, Cédric Bosch, Laurent Briottet, Maxime Bertin, Olivier Levasseur, Alain Leriverain

Hamza Ez-Zaki, Frédéric Christien, Cédric Bosch, Laurent Briottet, Maxime Bertin, et al.. Effect of hydrogen content in natural gas blend on the mechanical properties of a L485-MB low-alloyed steel. PVP® 2020 Virtual Conference - Pressure Vessels & Piping®, Aug 2020, Mineapolis, United States. pp.V006T06A085, 10.1115/PVP2020-21228 . emse-03826773

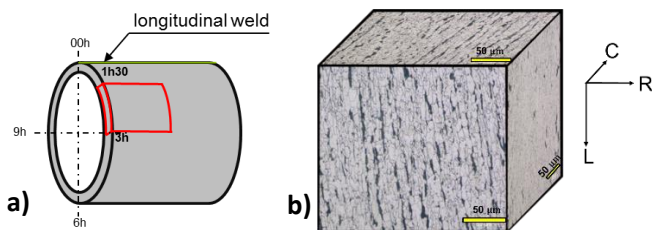
**Figure 1: a) Localization of the pipe section of the L485-MB steel, b) microstructure of the L485-MB steel in the Longitudinal (L), Circumferential (C) and Radial (R) directions**

The C-Mn low alloy steel L485-MB (NFEN ISO 3183) was supplied by GRTgaz as a section of pipeline (800 mm nominal

diameter and 19.2 mm wall thickness) as shown in Figure 1.a. The L485-MB steel composition is summarized in Table 1.

The microstructure of the L485-MB was analyzed in all directions of the pipeline (Figure 1.b). The surface of all specimens were polished mechanically with 800, 1200, 2400 and 4000 grade SiC papers, followed by a 6  $\mu m$ , 3  $\mu m$  and 1  $\mu m$  diamond polishing. Then, the surfaces were observed with an optical microscope (OM) after a 5 sec chemical attack with a Nital 3% solution (3%  $HNO_3$  in ethanol (98%)). The steel microstructure is constituted of ferrite and pearlite. The pearlite is aligned along the longitudinal and circumferential direction caused by initial hot rolling of the plate. Based on image analysis applied to the same plane, the volume fraction of pearlite was estimated to 10-12 %, which is close to the theoretical fraction (12.5%) calculated using the lever rule from a phase diagram obtained by the Thermo-calc<sup>TM</sup> software.

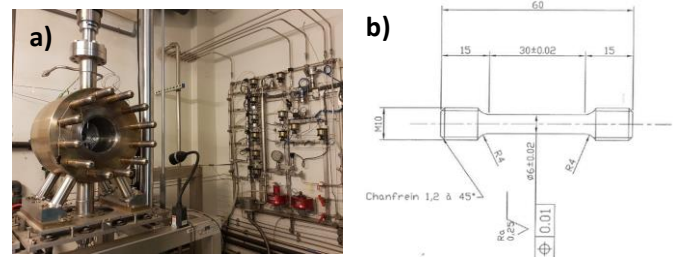
**Figure 2: a) MTS servo hydraulic testing machine under high pressure gas, b) geometry of the cylindrical smooth tension specimens**

Tensile tests in high pressure gas were performed on a MTS servo hydraulic testing machine (Figure 2.a) in a dedicated pressure vessel at room temperature. To guarantee the control of the gas content, specifically in terms of impurities, a specific procedure was followed. Several cycles including a primary vacuum followed by filling with nitrogen (N60 purity: 99.9999%) were done. Then, the testing gas is flushed through the system during several minutes. The pressure vessel was then filled with the testing gas to the required pressure (0.2, 2.1 and

In this study, two surface roughnesses (0.5 $\mu m$  and 0.03 $\mu m$ ) of the cylindrical smooth tensile specimens have been addressed (Figure 2.b). Moreover, two slow strain rates  $10^{-4} s^{-1}$  and  $10^{-6} s^{-1}$  corresponding respectively to 0.0018 mm/min and 0.18 mm/min displacement rates of the hydraulic cylinder of the testing machine. The specimens were machined in the circumferential direction of the pipeline which corresponds to the highest loading direction in a pipeline under pressure. Yield stress (YS), Ultimate Tensile Stress (UTS), Total Elongation (TE) and Reduction Area (RA) were quantified under different gas conditions (0.2, 2.1 and 8.5 MPa of pure Hydrogen, 8.5 MPa x% $H_2$ -NG mixtures). The tensile tests in different environments have been doubled to confirm the obtained results.

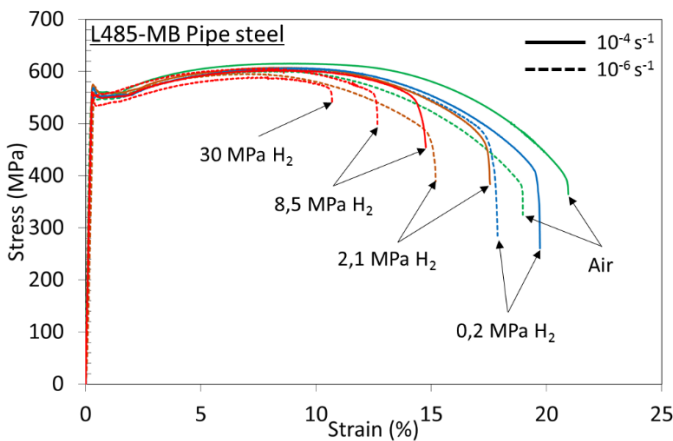
**Figure 3:** engineering stress (MPa) vs. strain (%) for the L485-MB low alloyed pipe steel in different pressure of high-purity hydrogen gas (N55 : >99.9995%) and ambient air. Two strain rates were used  $10^{-4}$ s $^{-1}$  (solid line) and  $10^{-6}$ s $^{-1}$  (dashed line)

Low strain rate tensile tests in high purity hydrogen gas (N55) were performed at room temperature at different pressure of hydrogen (0.2, 2.1, 8.5 and 30 MPa). The main objective is to quantify the embrittlement of the L485-MB steel with the increase of hydrogen pressure. Tensile test curves are plotted in Figure 3 with different experimental conditions. A decrease of elongation at rupture was observed with the increase of hydrogen pressure for both  $10^{-4}$  and  $10^{-6}$  s $^{-1}$  strain rates. The effect of hydrogen was stronger at lower strain rate. However, the tensile test curves indicate that hydrogen has no significant effect on YS and UTS or, if any, the small effect is within the heterogeneity of the material.

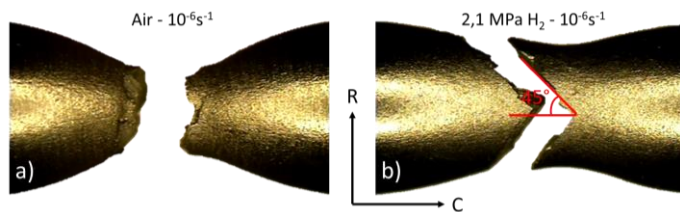
**Figure 4:** a) Cup and cone fracture mode in ambient air at  $10^{-6}$ s $^{-1}$ , b) shear fracture mode in 2.1 MPa high-purity hydrogen gas at  $10^{-6}$ s $^{-1}$

The tensile specimens tested in air broke with a classical cup and cone type fracture (Figure 4.a) which corresponds to a large amount of plastic deformation before final failure. Under hydrogen, the fracture mode is changed. A fracture path inclined at 45° from the loading direction was observed (Figure 4.b).

According to Figure 4 and Figure 6, a similarity is observed at the same partial pressure (2.1 MPa) of hydrogen in terms of fracture mode.

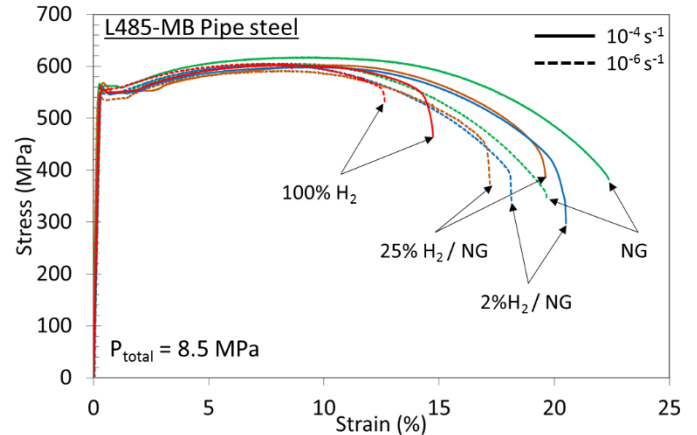
**Figure 5:** Engineering stress (MPa) vs. strain (%) for the L485-MB low alloyed pipe steel in different %H<sub>2</sub>-NG blends at 8.5 MPa total pressure. Two strain rates were used  $10^{-4}$ s $^{-1}$  (solid line) and  $10^{-6}$ s $^{-1}$  (dashed line)

Tensile tests in NG-H<sub>2</sub> blends were performed at room temperature with several hydrogen contents (0%, 2%, 25% and 100%) at a total pressure of 8.5 MPa (Figure 5). In order to compare with the previous results (Paragraph.3.1), the partial pressure of hydrogen in the blend corresponds approximately to the pressure used for tests in high-purity hydrogen gas.

The results show a decrease of total elongation with the increase of hydrogen content in natural gas (NG) at a given total pressure (8.5 MPa). The loss of ductility in H<sub>2</sub>-NG blends shows a similar tendency with the results in pure hydrogen in terms of partial pressure. Besides, these results confirm the effect of strain rate on hydrogen embrittlement: at a lower strain rate, the loss of ductility is greater.

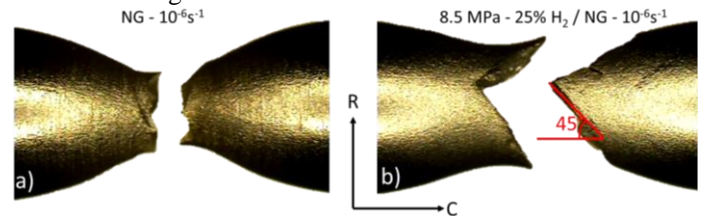
**Figure 6:** a) Cup and cone fracture mode in Natural Gas (NG) at  $10^{-6}$ s $^{-1}$ , b) shear fracture mode in 8.5 MPa 25% H<sub>2</sub>/NG (corresponding to 2.1 MPa of H<sub>2</sub>) at  $10^{-6}$ s $^{-1}$

The cup and cone fracture mode was also observed in NG and 2% H<sub>2</sub>/NG blend. However, in 25% H<sub>2</sub>/NG, a 45° fracture path from the loading direction is observed.

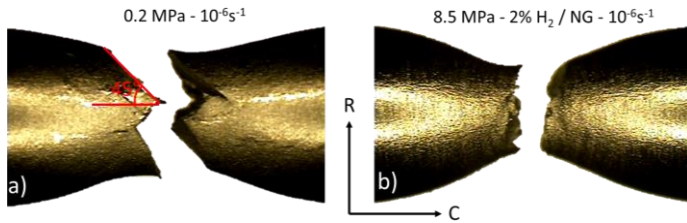
**Figure 7: Fracture mode in a) high-purity hydrogen and b) 2%  $\text{H}_2/\text{NG}$  blend at the same  $\text{H}_2$  partial pressure ( $\sim 0.2$  MPa)**

Nevertheless, at low partial pressure (~0.2 MPa), the fracture modes are quite different between pure hydrogen and 2% H<sub>2</sub>/GN blend as shown in Figure 7.

At a sufficient partial pressure ( $> 2$  MPa), these results confirm that it is possible to consider the hydrogen partial pressure to evaluate the HE sensitivity of the material. By contrast, at low hydrogen partial pressure and low strain rate, the material behavior is not the same in the blend or in pure hydrogen.

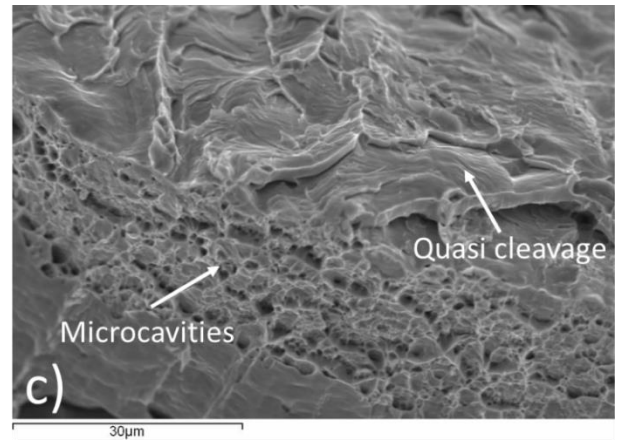
**Figure 8: Fracture surfaces from L485-MB pipeline steel tested at room temperature in 8.5 MPa of 25%  $\text{H}_2/\text{NG}$  blend at  $10^{-6} \text{ s}^{-1}$ , a) ductile fracture surface, b) hydrogen affected zone (HAZ) observed in a large area of the fracture surface, c) a mixed zone of quasi cleavage and micro-cavities observed along a pearlite alignment**

The fracture surfaces of the tested specimens were observed in a scanning electron microscope (SEM). Three different main areas were identified (Figure 8). The proportion of each area depends on the partial pressure of hydrogen in the gas and on the imposed strain rate.

In ambient air, the dominant feature observed is a classical ductile-dimple type fracture similar to Figure 8.a which corresponds to a high plastic deformation before final failure. The same fracture surface is observed in natural gas and 2%  $\text{H}_2/\text{NG}$  blend (Figure 9.a).

By contrast, in high partial pressure ( $> 2.1$  MPa) of hydrogen the fracture surfaces change dramatically. A quasi-cleavage type fracture (Figure 8.b) becomes dominant with the presence of delamination along the pearlite planes (Figure 9.b). Moreover, microcavities were observed along delamination which correspond to the ferrite inside the pearlite microstructure (Figure 8.c). Besides, the necking was significantly reduced in high partial pressure of hydrogen compared to NG and air as shown in Figure 9.

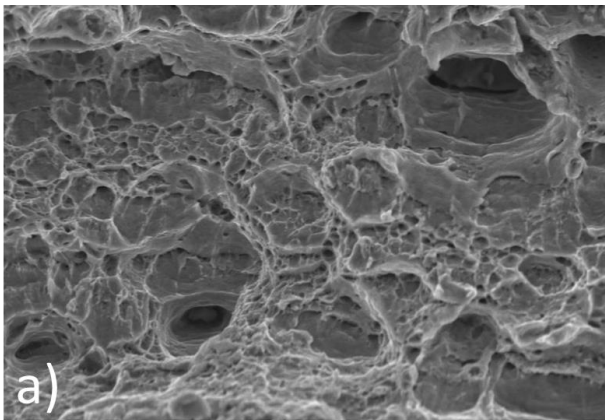
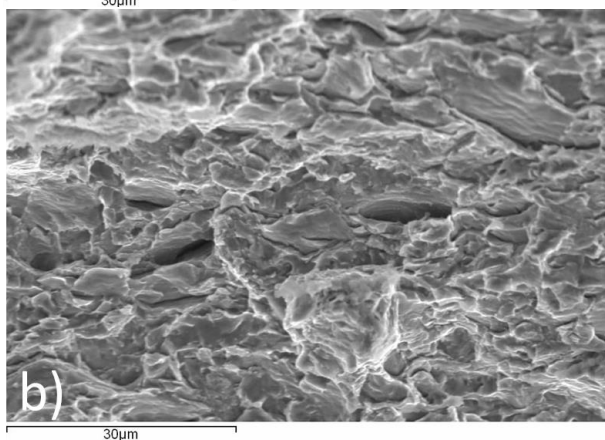
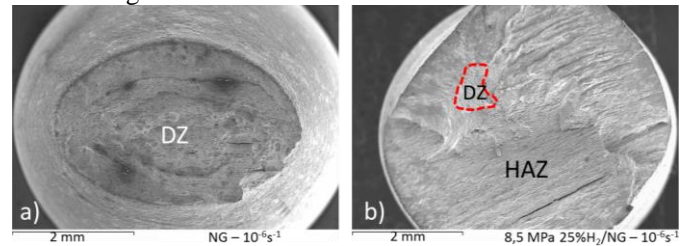
**Figure 9: Fracture surfaces from L485-MB at room temperature in a) Natural Gas (NG) and b) 8.5 MPa 25%  $\text{H}_2/\text{NG}$  blend at  $10^{-6} \text{ s}^{-1}$  strain rate. DZ: Ductile Zone and HAZ: Hydrogen Affected Zone**

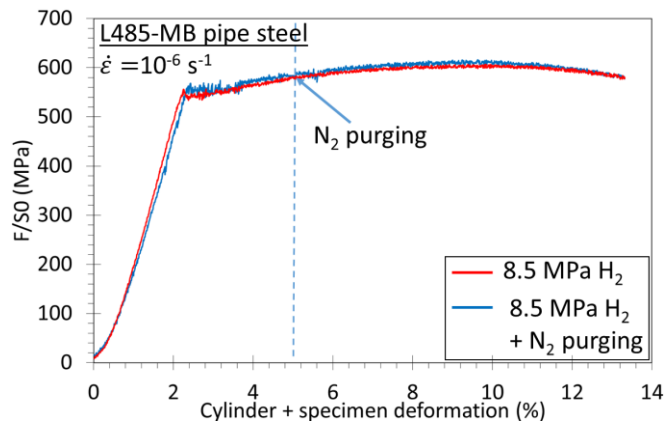
**Figure 10: Interrupted tensile test for the L485-MB pipeline steel in 8.5 MPa H<sub>2</sub> (red curve) and 8.5 MPa H<sub>2</sub> followed by a N<sub>2</sub> sweeping (blue curve)**

Two smooth specimens were loaded up to 4 mm of axial displacement of the hydraulic cylinder corresponding to 13% of total deformation of the cylinder + specimen (Figure 10) at  $10^{-6} \text{ s}^{-1}$  strain rate. The first specimen (blue curve) was deformed in 8.5 MPa high-purity hydrogen followed by a nitrogen purging as indicated by the blue arrow. Whereas the second specimen (red curve) was fully strained in 8.5 MPa high-purity hydrogen.

Interrupted tensile test curves in both environment H<sub>2</sub> and H<sub>2</sub>/N<sub>2</sub> show a similar mechanical behavior. However, at a finer scale observation of the specimen surfaces, cracks appear only for the specimen deformed completely in H<sub>2</sub> (red curve of Figure 10). SEM observation of the specimen side shows two types of cracks: small cracks (L~10μm) perpendicular to the loading direction (Figure 11-red arrows) and larger cracks (100 μm < L < 2mm) inclined at 45° from the loading direction. Besides, small cavities (D<sub>cavity</sub> < 100 μm) were observed in the necking zone as shown in Figure 11.

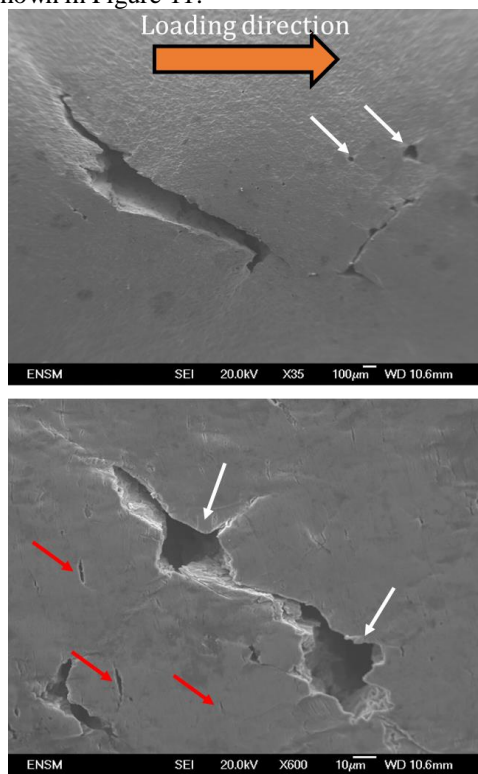
**Figure 11: SEM observation of the specimen surface of L485-MB pipeline steel deformed in 8.5 MPa high-purity hydrogen and interrupted in the necking zone. The red arrows indicate the perpendicular cracks and white arrows the observed cavities**

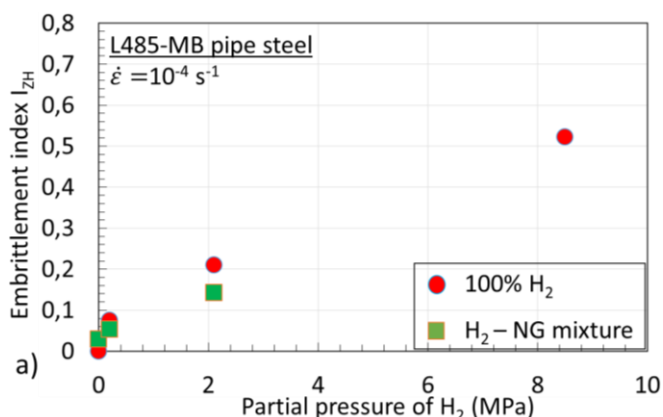
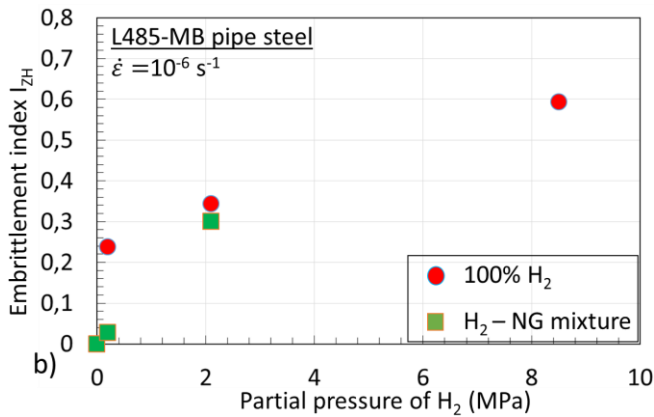
**Figure 12: The effect of partial pressure of hydrogen on the embrittlement index  $I_{ZH}$  at a)  $10^{-4}s^{-1}$  and b)  $10^{-6}s^{-1}$  strain rate**

The embrittlement index I<sub>ZH</sub> in different environment is plotted versus the partial pressure of hydrogen in Figure 12 at 10<sup>-4</sup>s<sup>-1</sup> and 10<sup>-6</sup>s<sup>-1</sup> strain rate.

The trend in embrittlement index  $I_{ZH}$  vs partial pressure in NG/H<sub>2</sub> mixture is similar to pure hydrogen with a slight difference, which correspond probably to the presence of impurities in NG. Otherwise, at low strain rate ( $10^{-6}s^{-1}$ ) and low partial pressure of H<sub>2</sub> (0.2MPa), a significant difference were observed between H<sub>2</sub>-NG mixture and high-purity hydrogen, which is also shown in Figure 7. In fact, the presence of impurities at low partial pressure of hydrogen mitigate the effect of H<sub>2</sub> on smooth specimen. Recently, T. T. Nguyen et al. <sup>6</sup> observed that 1% of H<sub>2</sub> in methane with a total pressure of 10MPa has no effect on mechanical properties of the X70 pipeline steel in a gaseous tensile test at  $10^{-4}s^{-1}$ . Nguyen concluded that 0.1 MPa partial pressure of hydrogen may not be high enough to increase the susceptibility to HE. However, in 0.2 MPa of high-purity hydrogen at a very low strain rate (0.0018mm/min), the L485-MB was susceptible to HE. In addition, Figure 13 shows the effect of surface roughness on the embrittlement index  $I_{ZH}$ . The results indicates that the sensibility to hydrogen embrittlement increases with the surface roughness. It is well known in surface science that surface defects increase the hydrogen adsorption and dissociation <sup>7</sup>. Consequently, a localization of hydrogen in the surface irregularities combined with the high stress concentration in waves may promote crack initiation and lead to premature fracture.

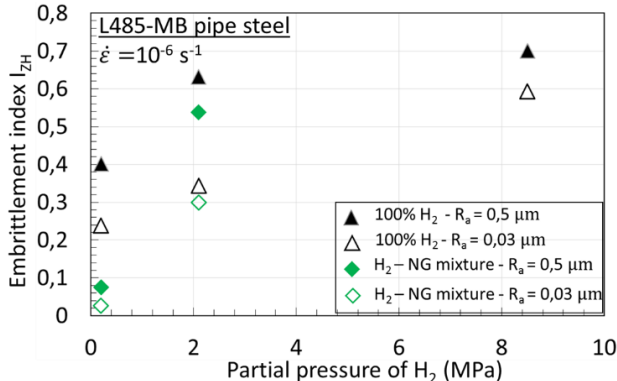
**Figure 13: Effect of surface roughness on the embrittlement index of the L485-MB pipeline steel**

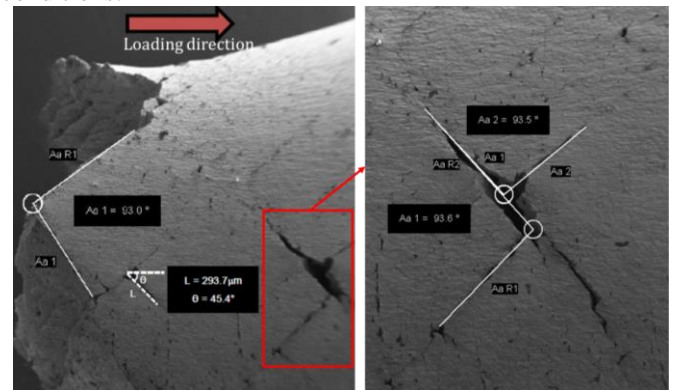
**Figure 14: Shear type fracture mode observed on the L485-MB pipeline steel in 2.1 MPa high-purity hydrogen at  $10^{-4}s^{-1}$  strain rate**

The analysis of fracture surfaces confirmed the consistence between hydrogen content in NG and partial pressure of hydrogen mainly at higher partial pressure. Two main regions were distinguished on fracture surfaces, a zone characterized by large dimples which corresponds to a ductile fracture, and a zone named “hydrogen affected zone” (HAZ) which corresponds to some quasi-cleavage zones mixed with small dimple areas. The HAZ becomes dominant with the increase of hydrogen partial pressure in NG. Moro et al. observed the same features in the X80 pipeline steel with the increase of hydrogen pressure <sup>2</sup>. However, the L485-MB present a shear type fracture mode oriented at 45 degrees to the loading direction (Figure 14), which is associated to the maximum shear stress, whereas Moro <sup>2</sup> and Nguyen <sup>6</sup> observed a perpendicular fracture to the loading direction. Nevertheless, Kwon et al. observed the same shear type fracture mode of a C-Mn steel (0.17 C, 1.29 Mn, 0.31 Si). In his study, hydrogen was introduced electrochemically using a cathodic current density of 2mA/cm<sup>2</sup> under controlled galvanostatic conditions for 24h at room temperature in a 1 N sulfuric acid solution poisoned with arsenic which is more severe than a gaseous charging <sup>8</sup>. The differences observed in fracture modes may be explained by the microstructure of each material and the severity of charging conditions.
